Marine Survey Report

/ Fethiye

Boat Name	[REDACTED]
Model	Moorings 41.3
Year	2011
HIN number	FR-SPBAN837A111
Boat builder	Beneteau
Flag	USA
LOA	12.17 m
Beam	3,96 m
Displacement	7680 kg
Vessel type	Monohull sloop sailing yacht
Engine model	Yanmar / 3JH5E

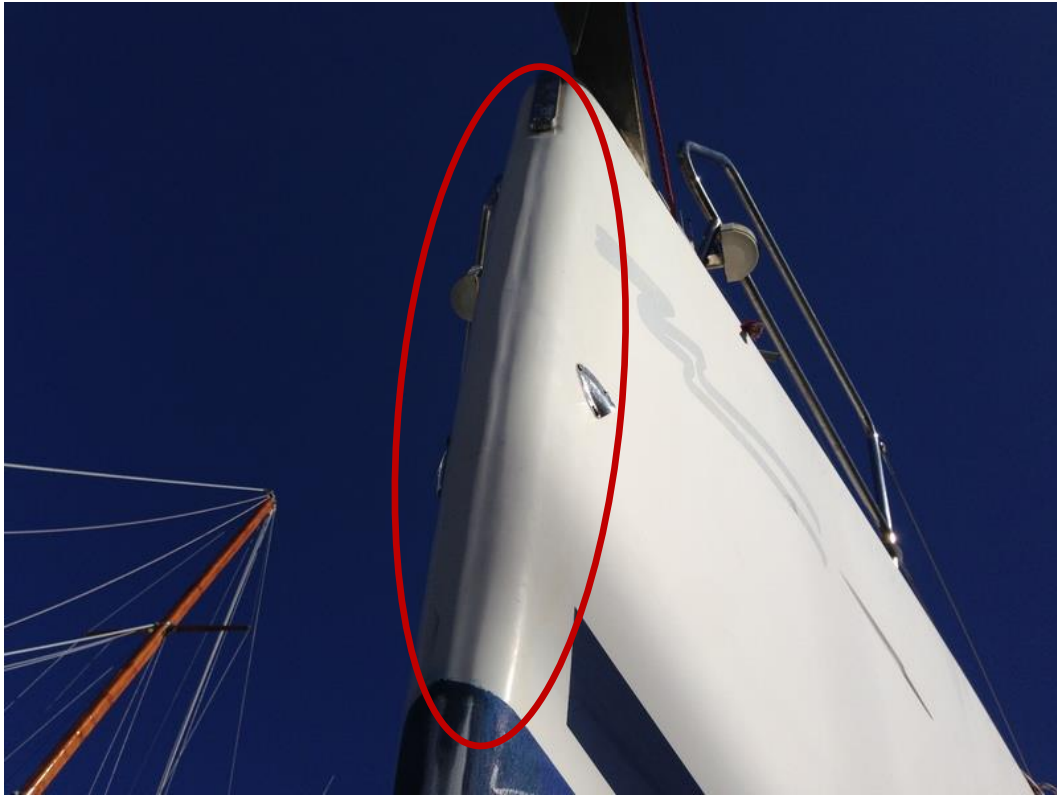
As you see at the above photograph, bow side of the boat was repaired before. The lines are not flat and symmetrical. Gelcoat repairment was done by brush on head of the boat. In some area, some grp reinforcement could be done.

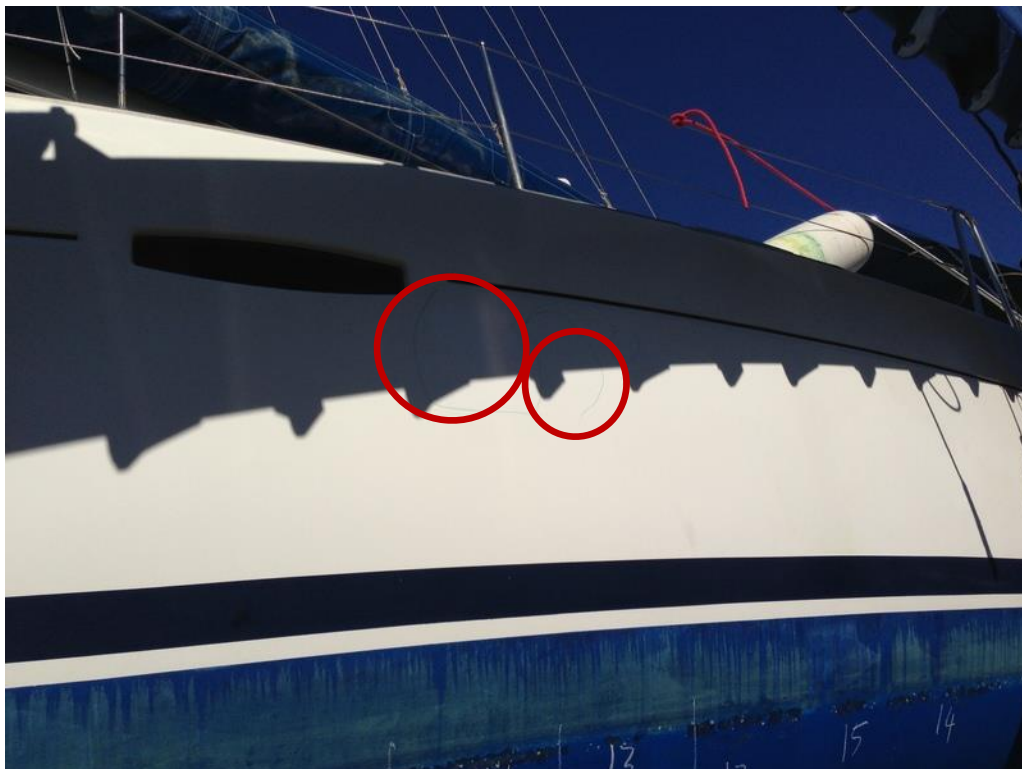
Gelcoat repairments on starboards side of topside, was shown in red marks. One is about 30 cm diameter and the other one is about 13 cm diameter. And also this surface is not flat. Inside the boat, repairment can not be seen so this must be only gelcoat repairment.

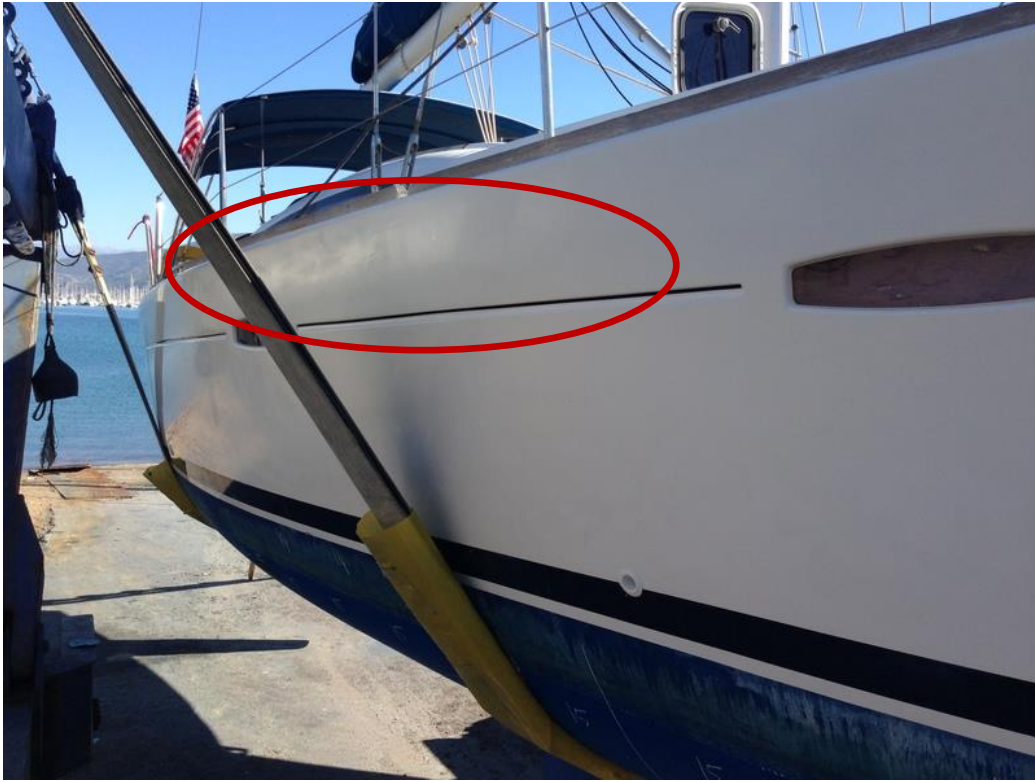
Topside white gelcoat surfaces are not shining enough. This was and then protection polish can be done before the next summer session.

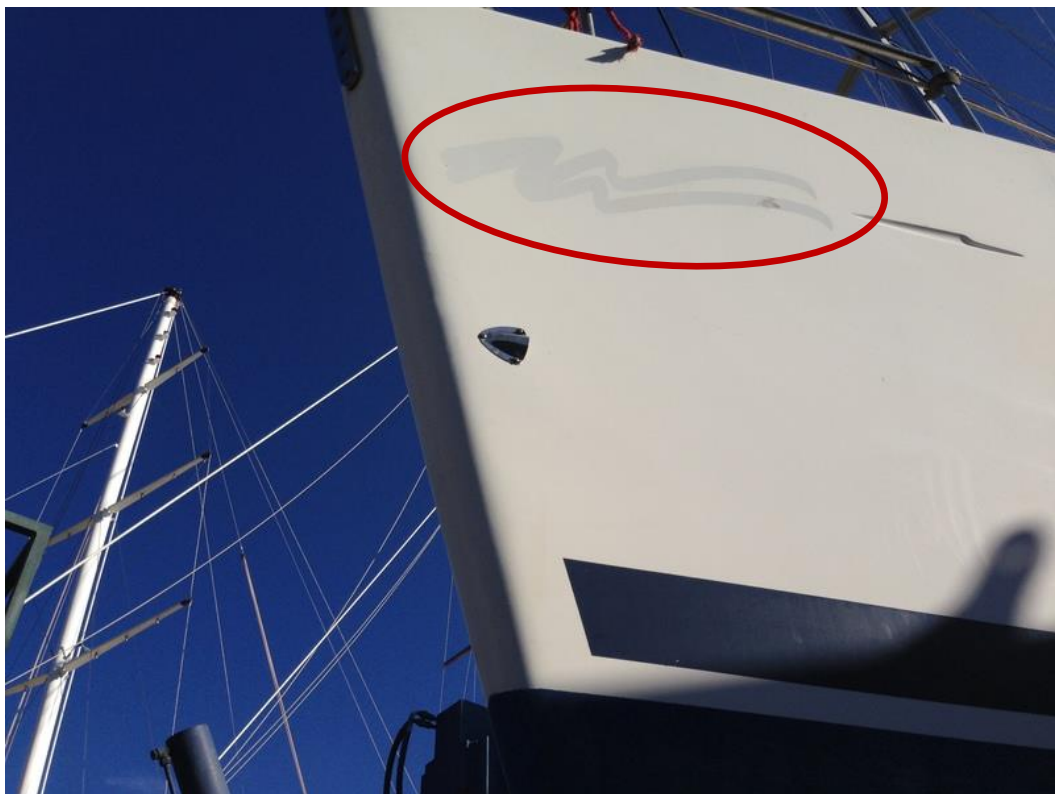
Bow topside of the boat and the aft side of the boat has Mooring's remaining sticker logos. These can be removed by applying wax.

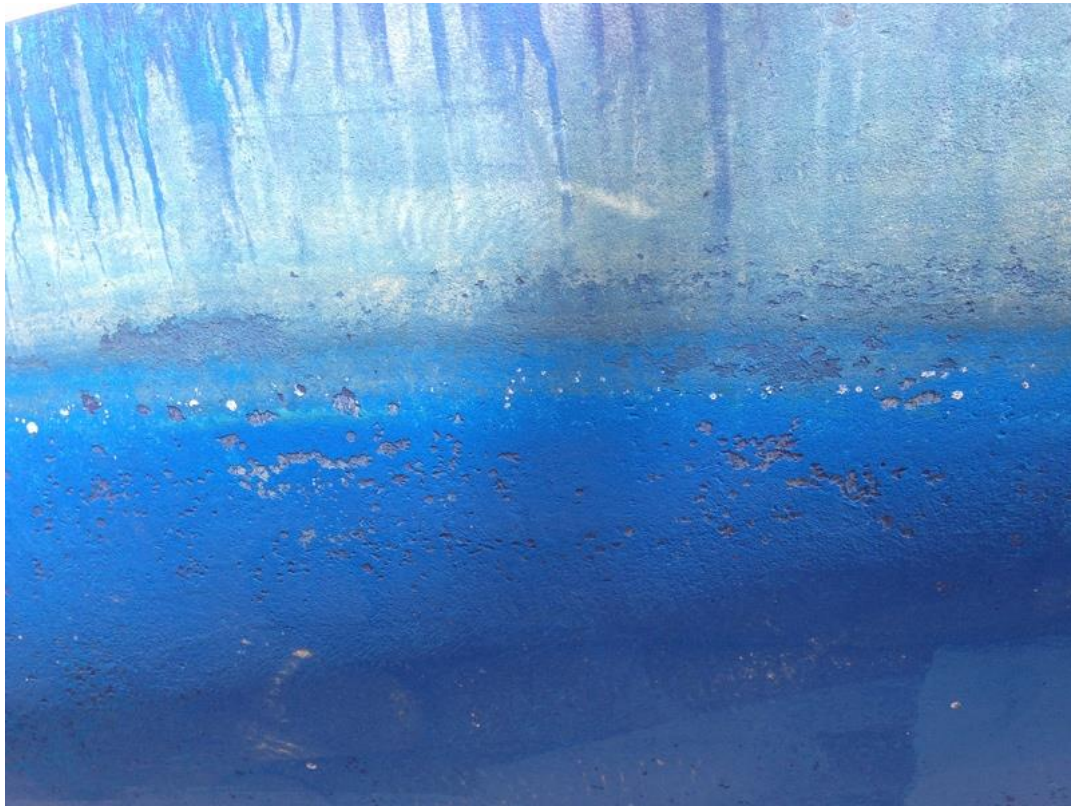
The hull antifouling below the waterline was too thick. Some places started peeling. For the next season, this antifouling must be removed. And also during the moister calculations, this thick antifouling shows much more moister on Tramex Moisture meter. Important repairment wasn't seen on keel area and grp parts under waterline.

Peeling antifouling that was because of thickness, can be seen on the above photo.

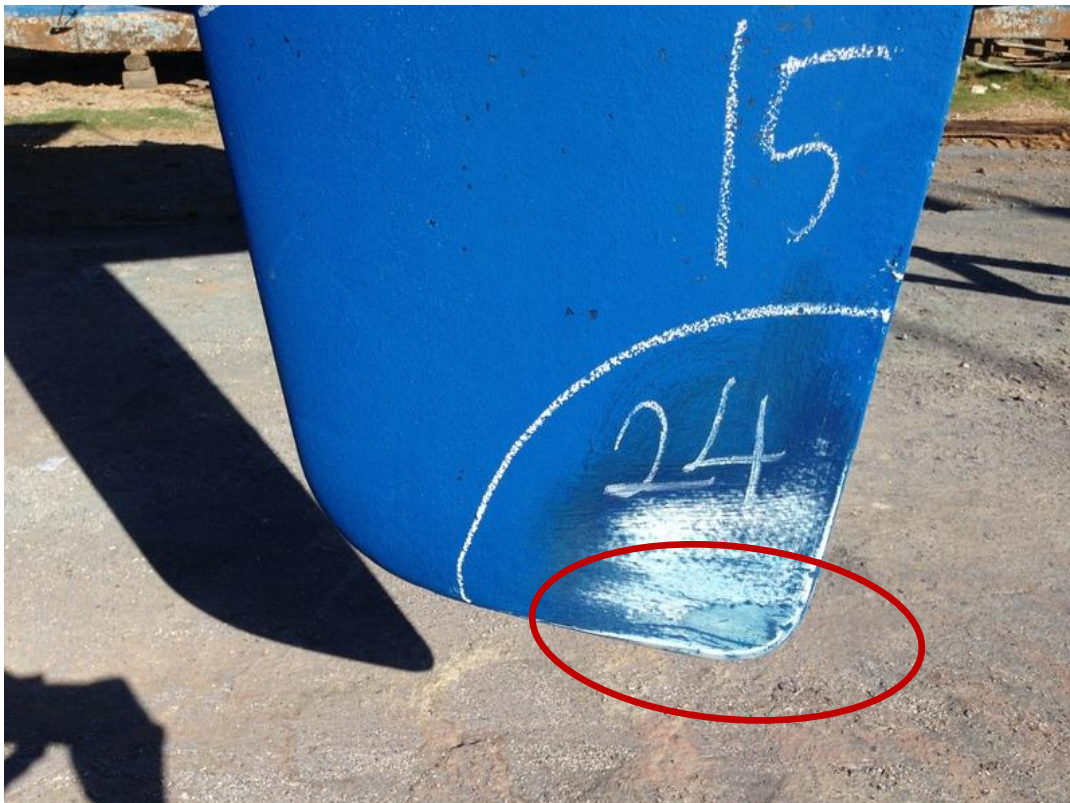
As seen on photo, edges of the rudder was repaired before by International filler. Because of this, moisture meter shows medium value moisture on that area.

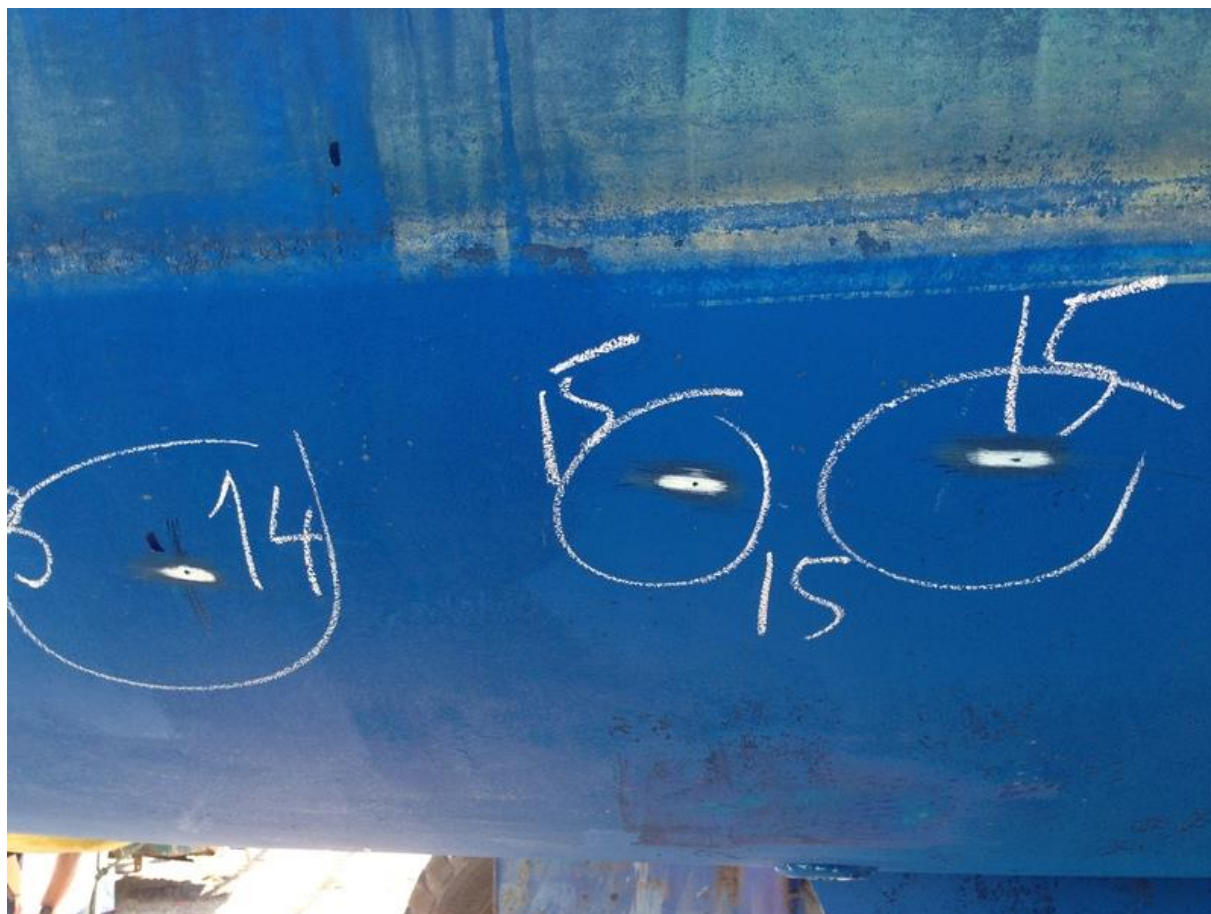
Starboard hull, three gelcoat pin holes found during the survey. GRP part of the boat can be seen from this holes. These holes are most probably caused by bubbles staying on gelcoat during the production. Moisture meter levels show, grp doesn't have moisture inside.

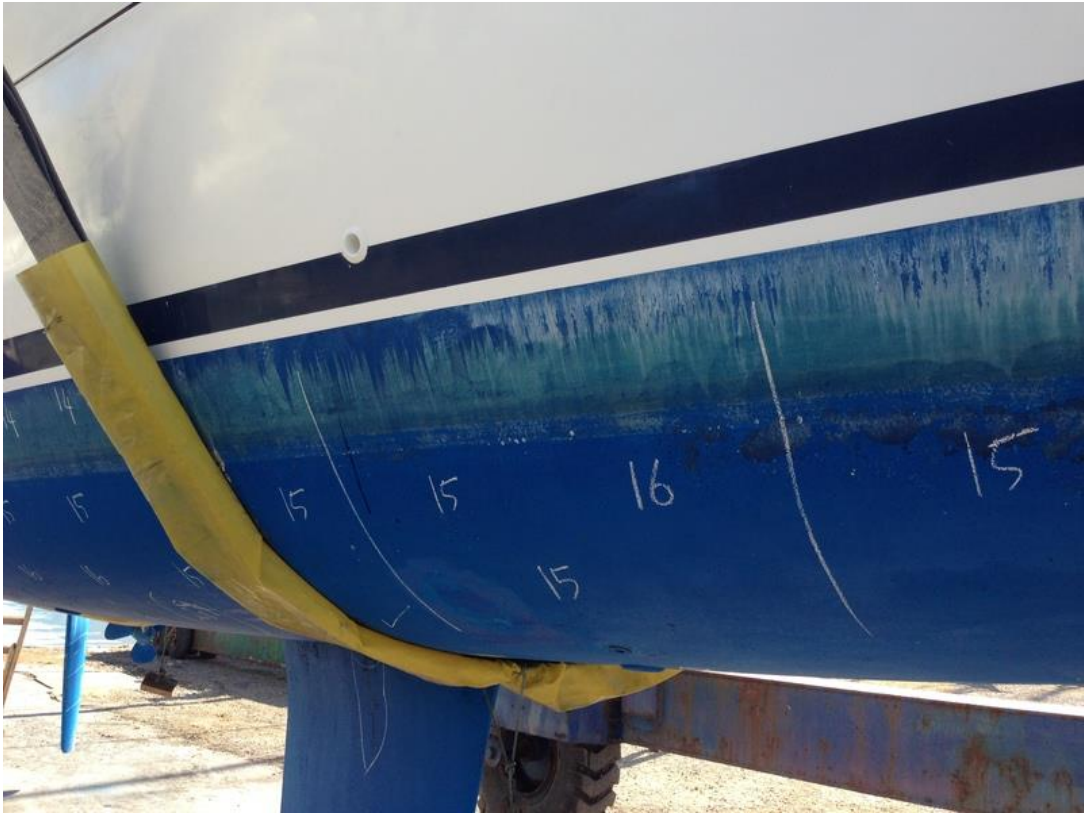
General moisture on grp was about 15%. This is acceptable level for one day standing boat on land.

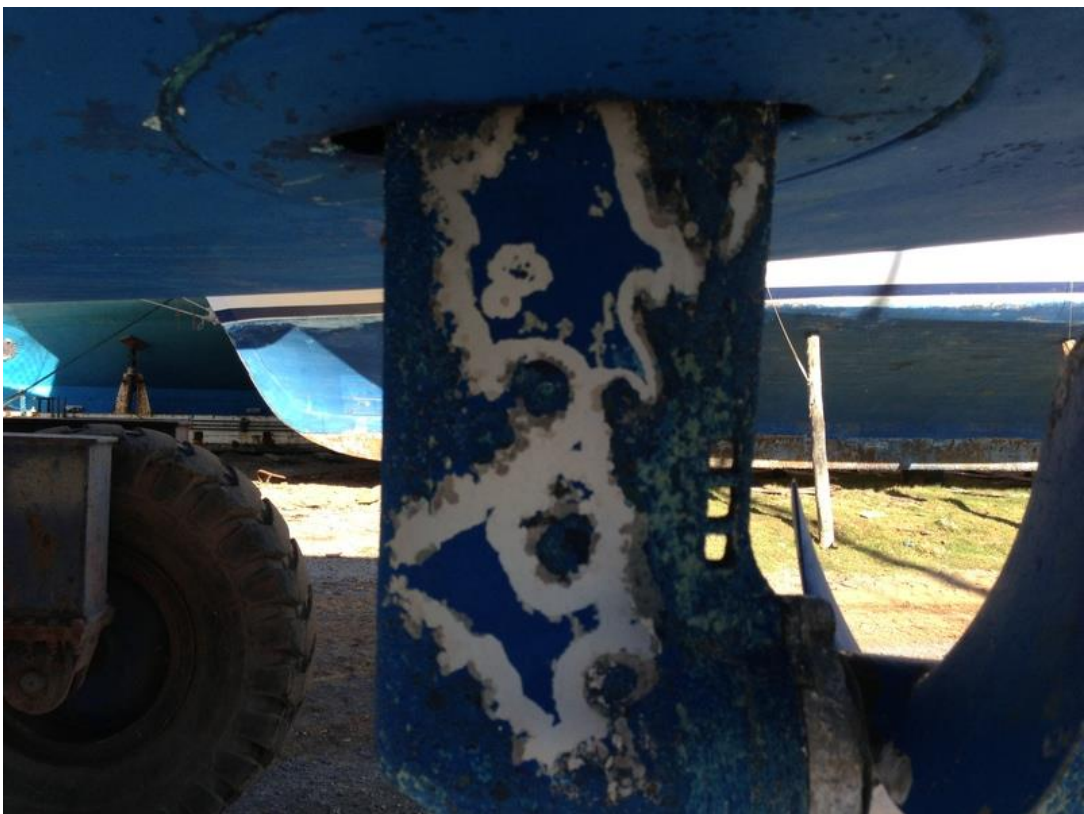
Sail-drive transmission system and three blade fixed propeller has not corrosion but they were painted with dark blue antifouling. Applying this grp antifouling is not acceptable for engine manufacturer. These must be painted by special metal antifouling.

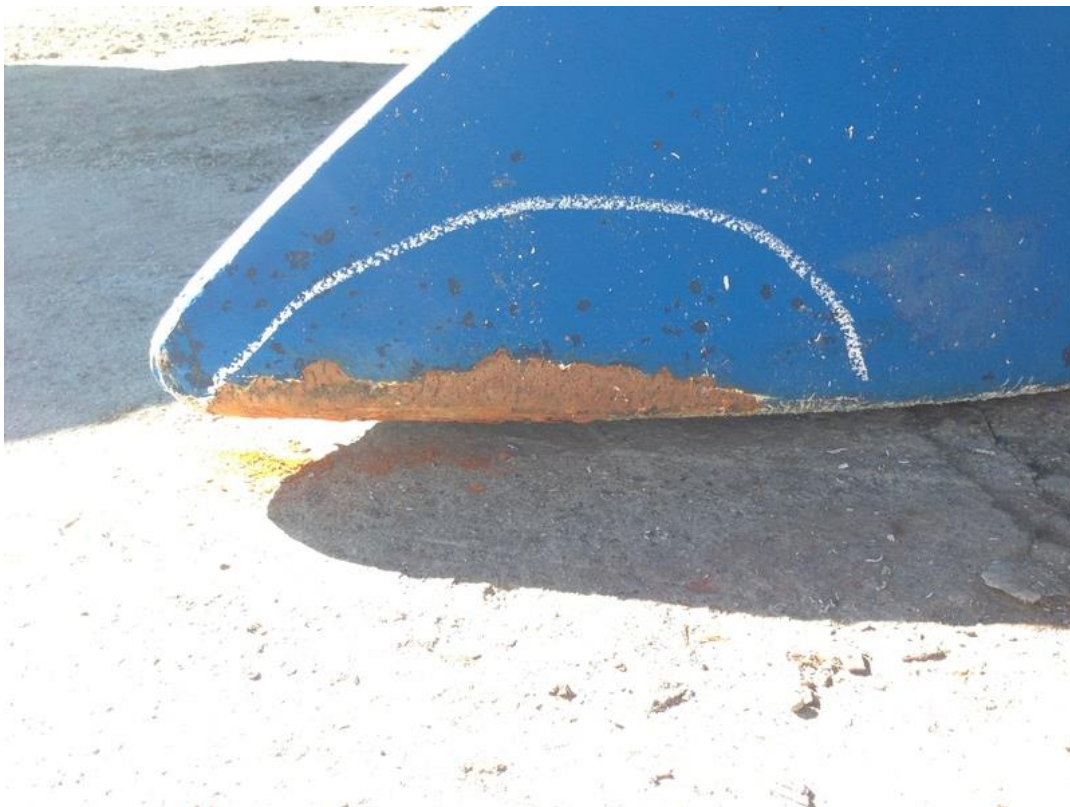
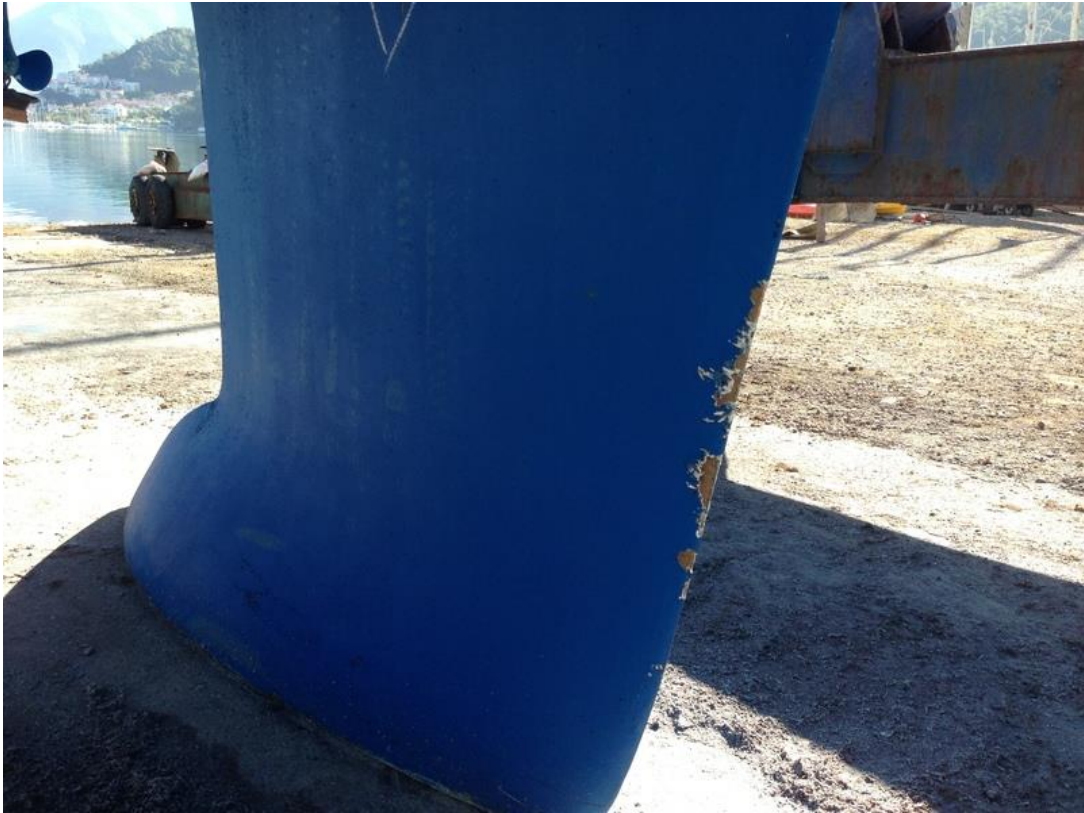
Bottom and bow side of the keel has some damages.

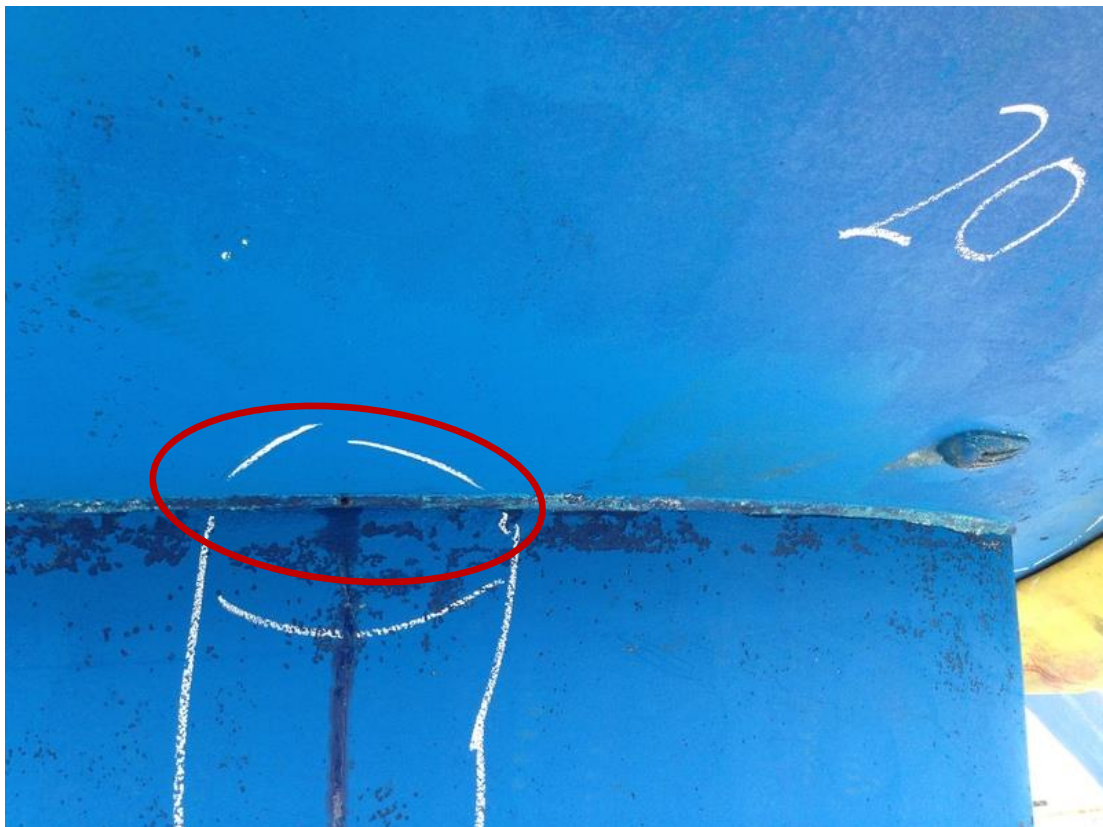
A hole type detachment on sealing between grp hull and keel.

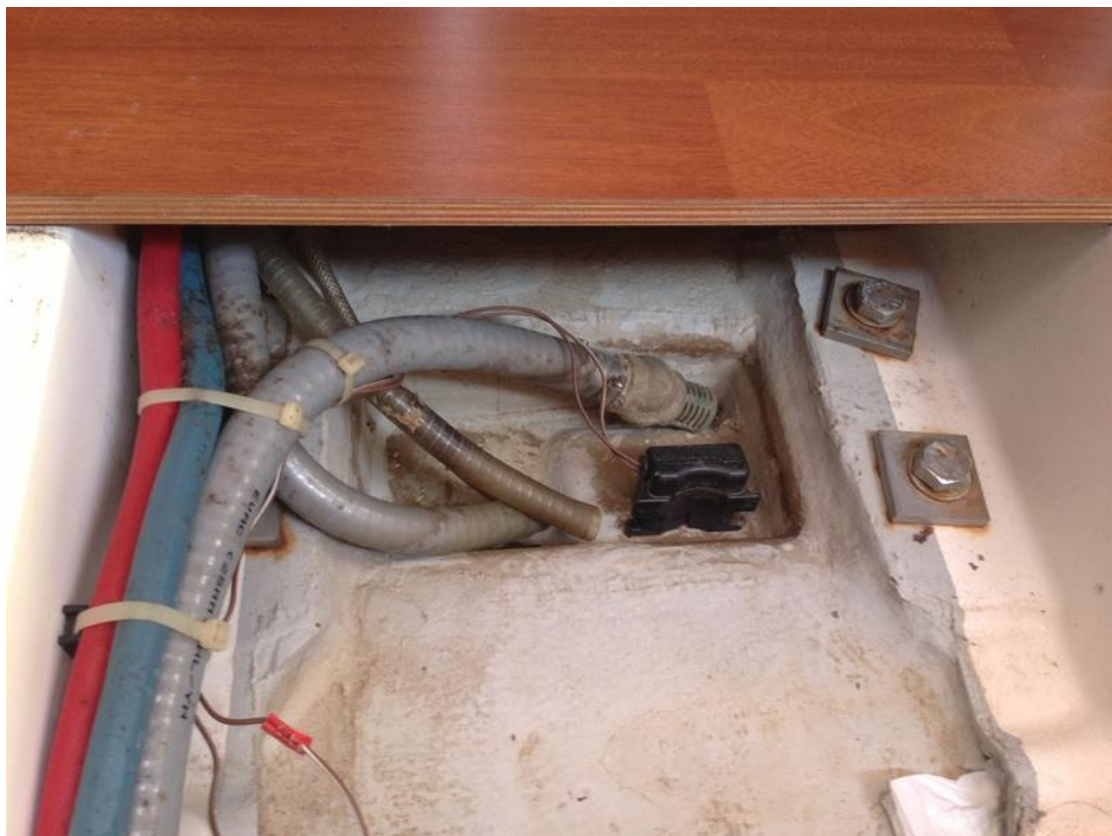
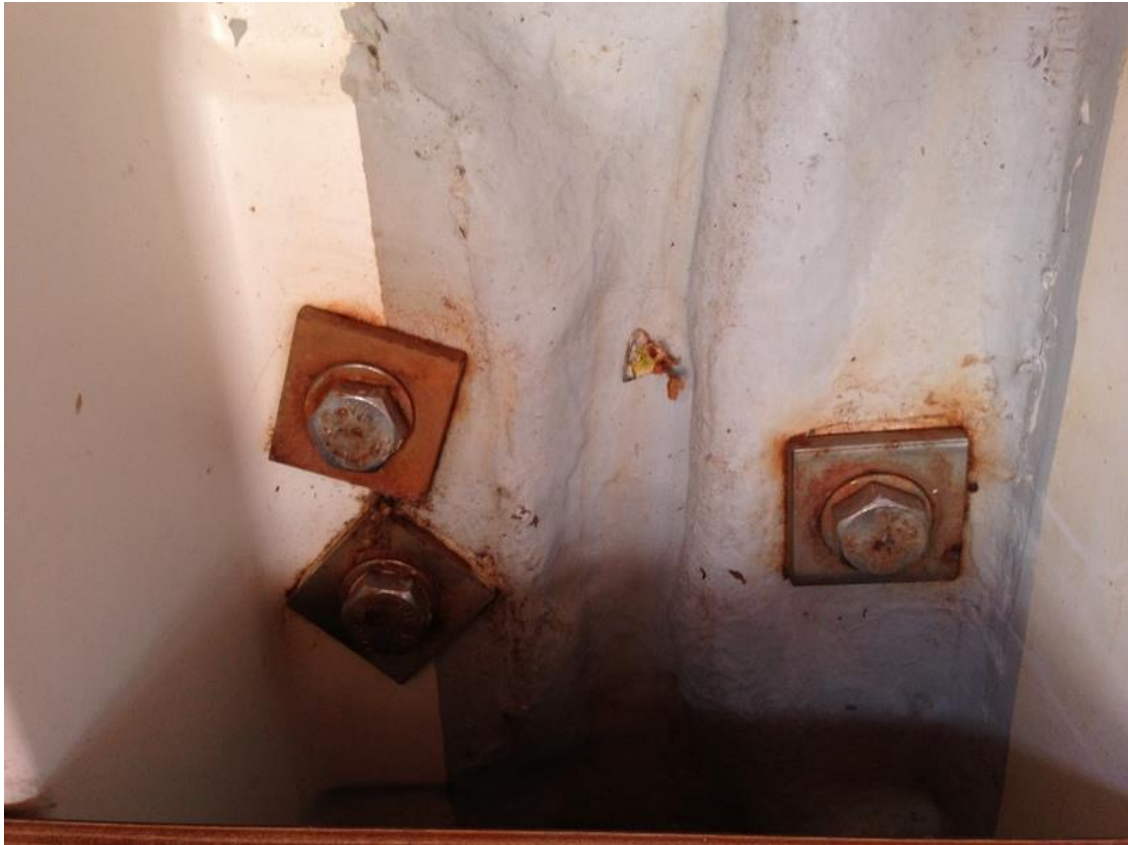
Rusty keel connection was seen on the bow side of boat. This is because, air condition makes some water while working and water passes from these places to the bilge pump.

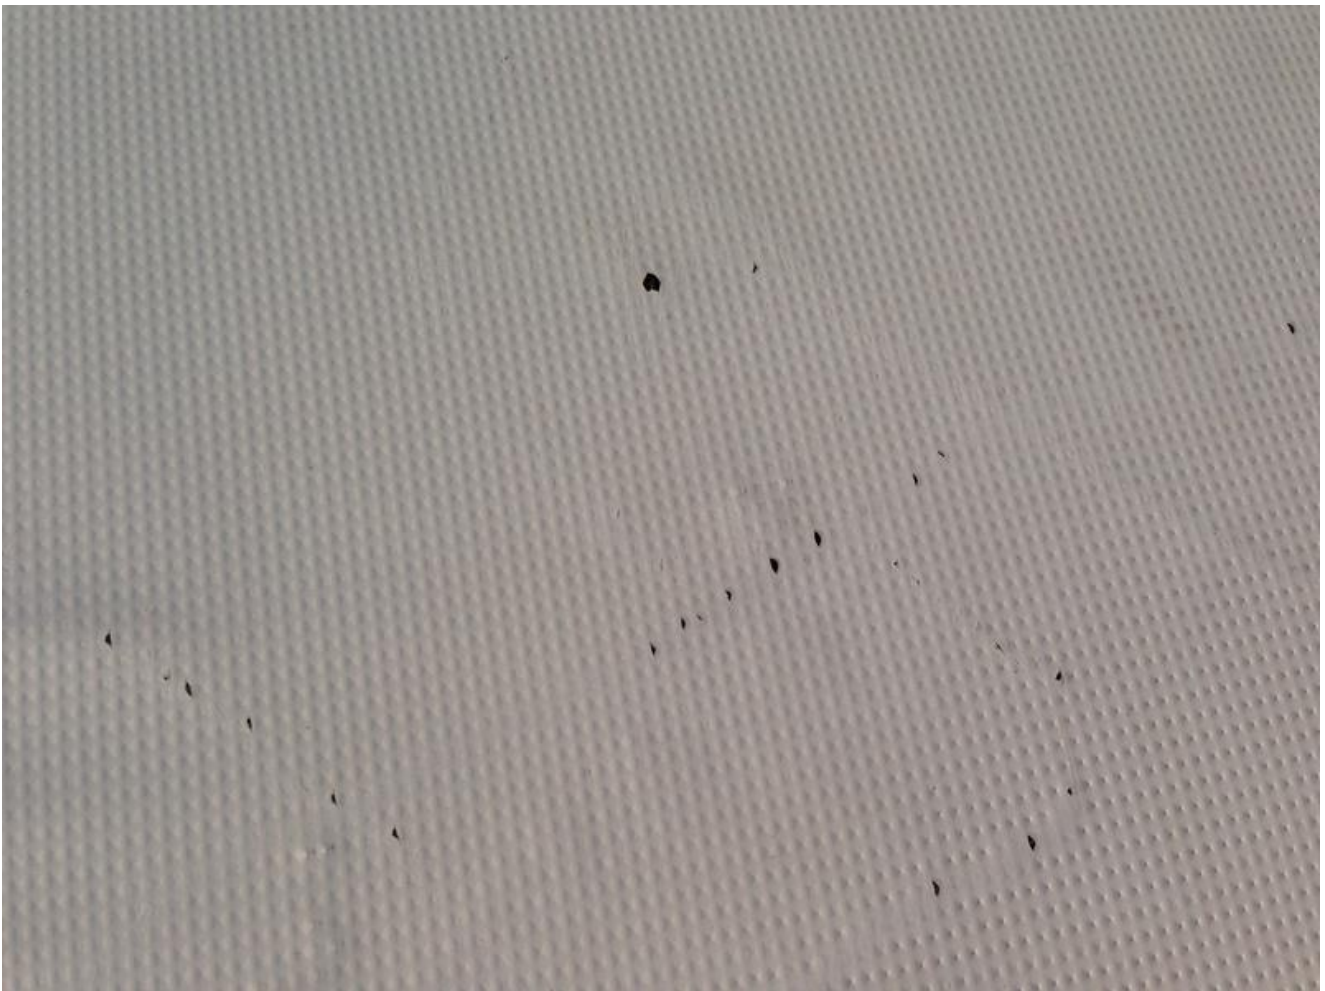
Some non-slip surface gelcoat finishing places on coach roof had too many damaged areas.

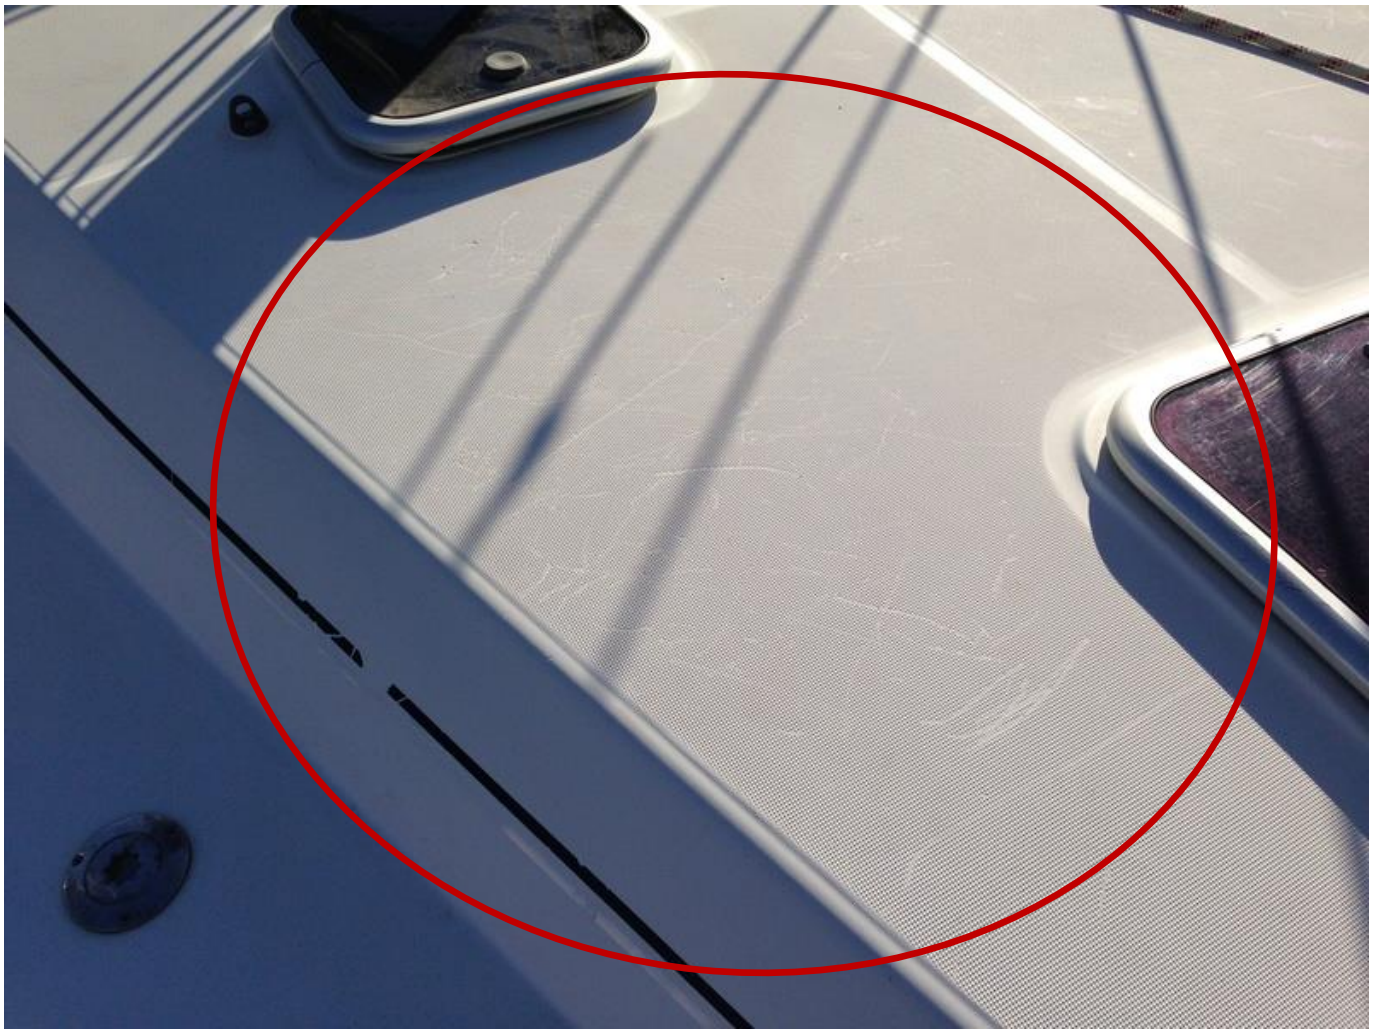
Too many scratches were seen on non-slip surface above the coach roof.

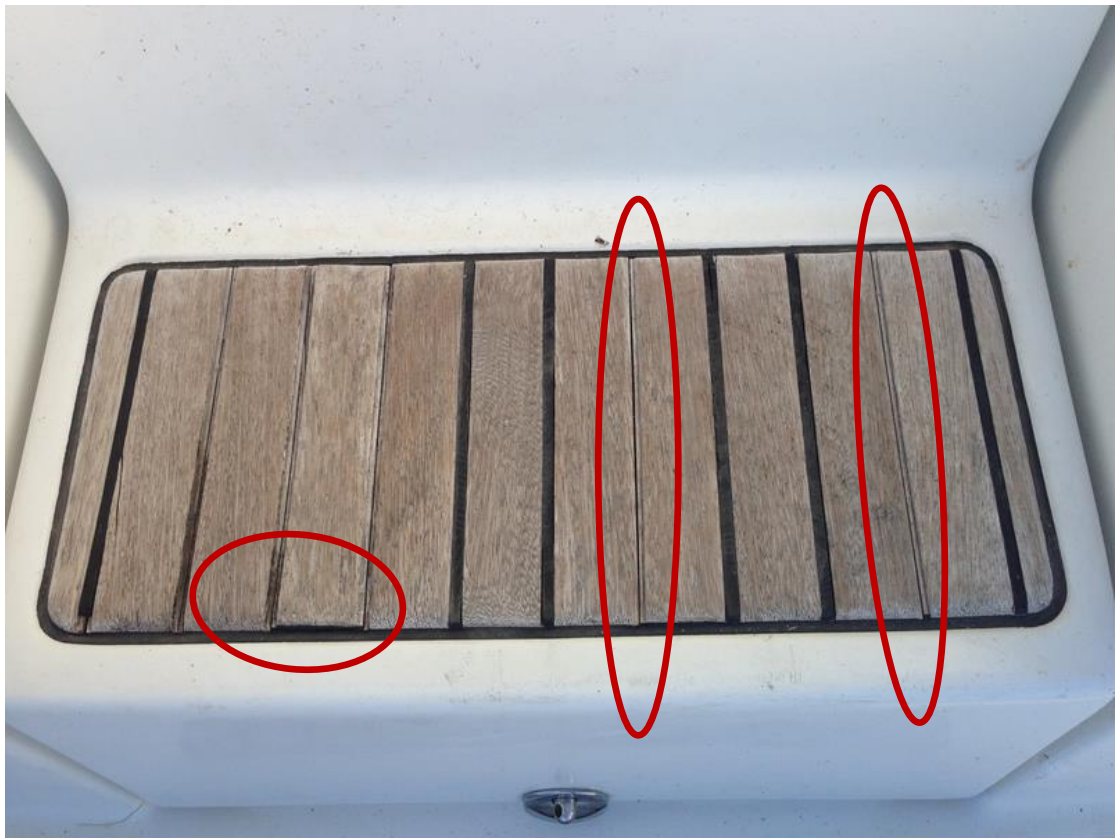
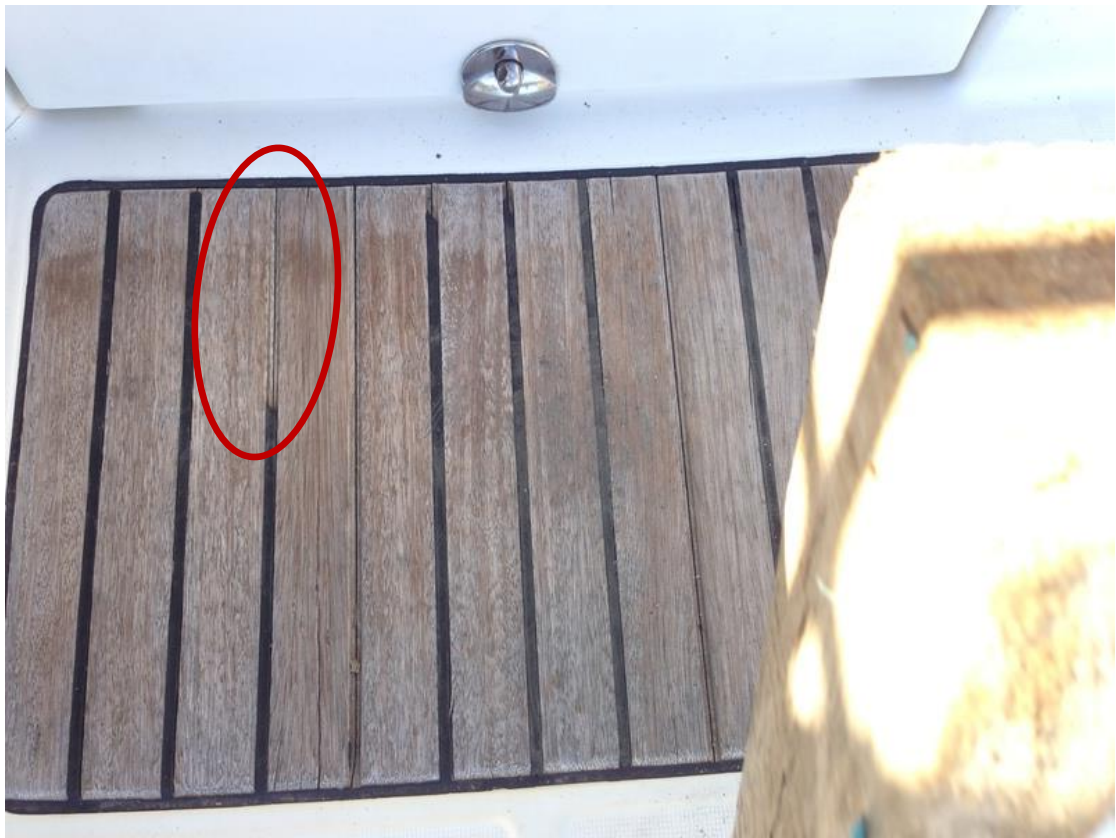
Black caulking was removing and some teak wood started getting from their bonding places. Especially black caulking on aft stairs was not seen.

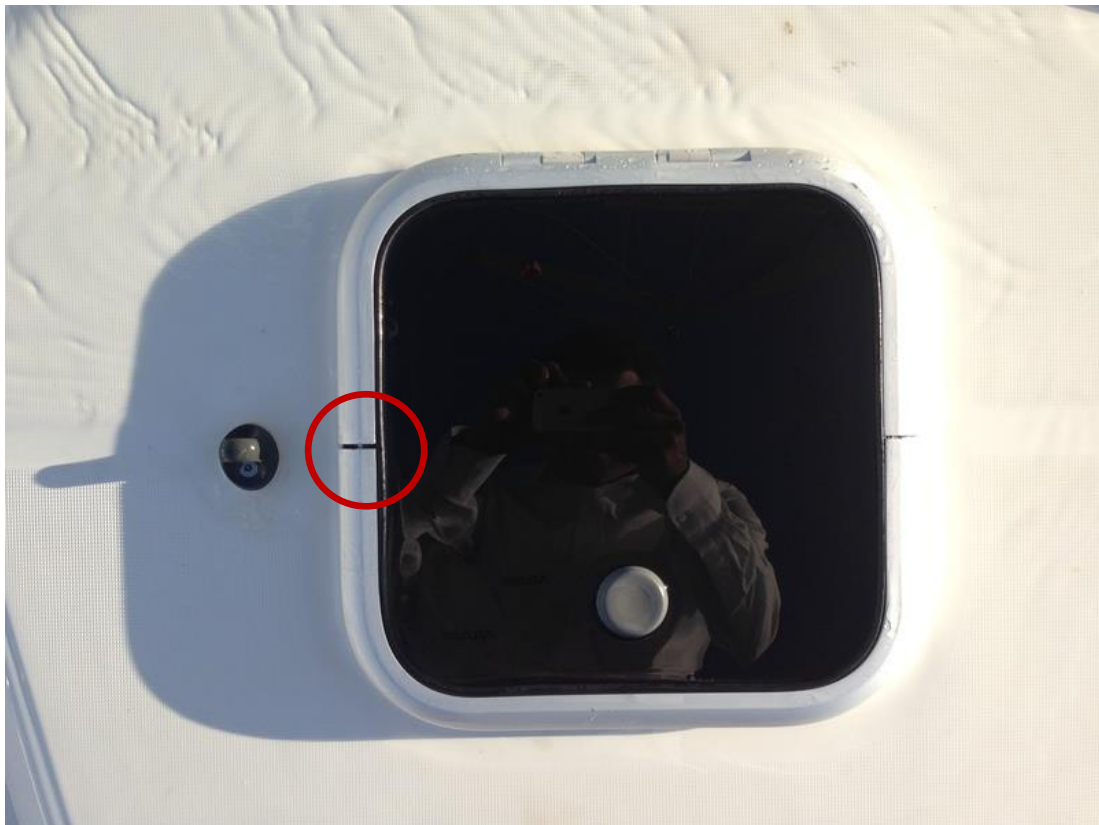
Detachment was seen on starboard side hatch that was located on coach roof.

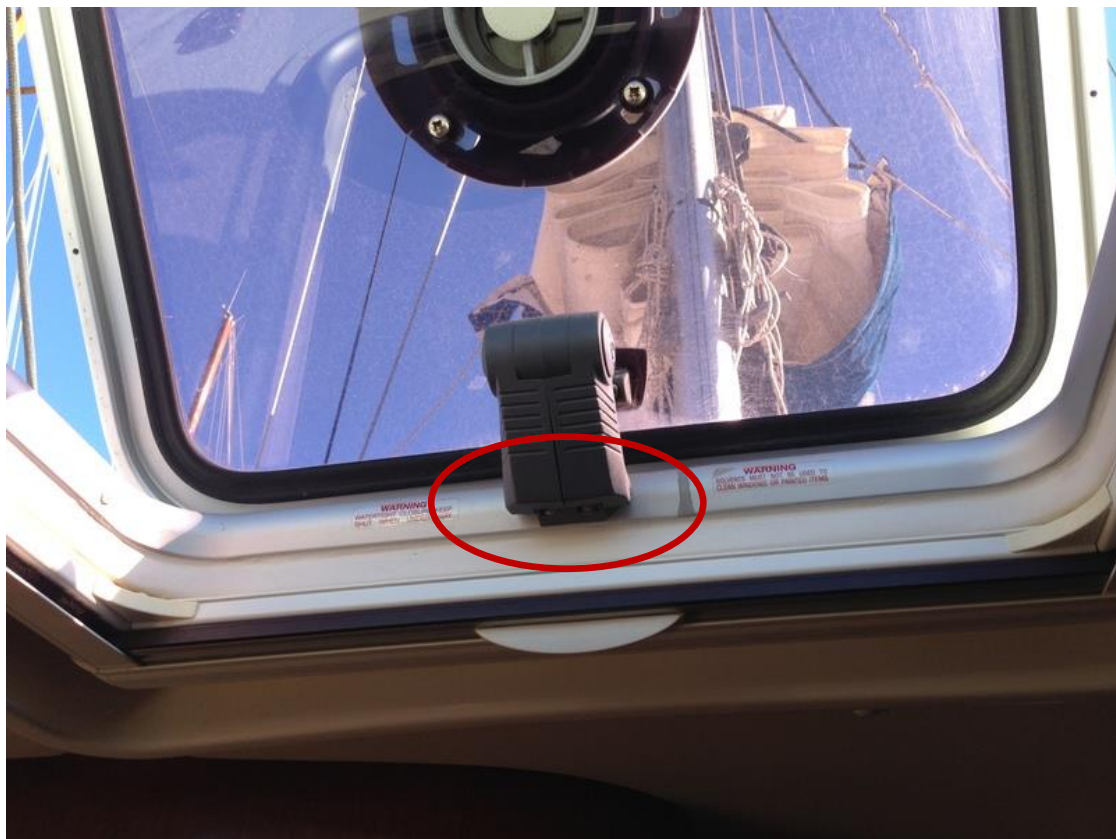
Shown place of hatch supporting rivets were not tight enough. In time they will loosen much more.

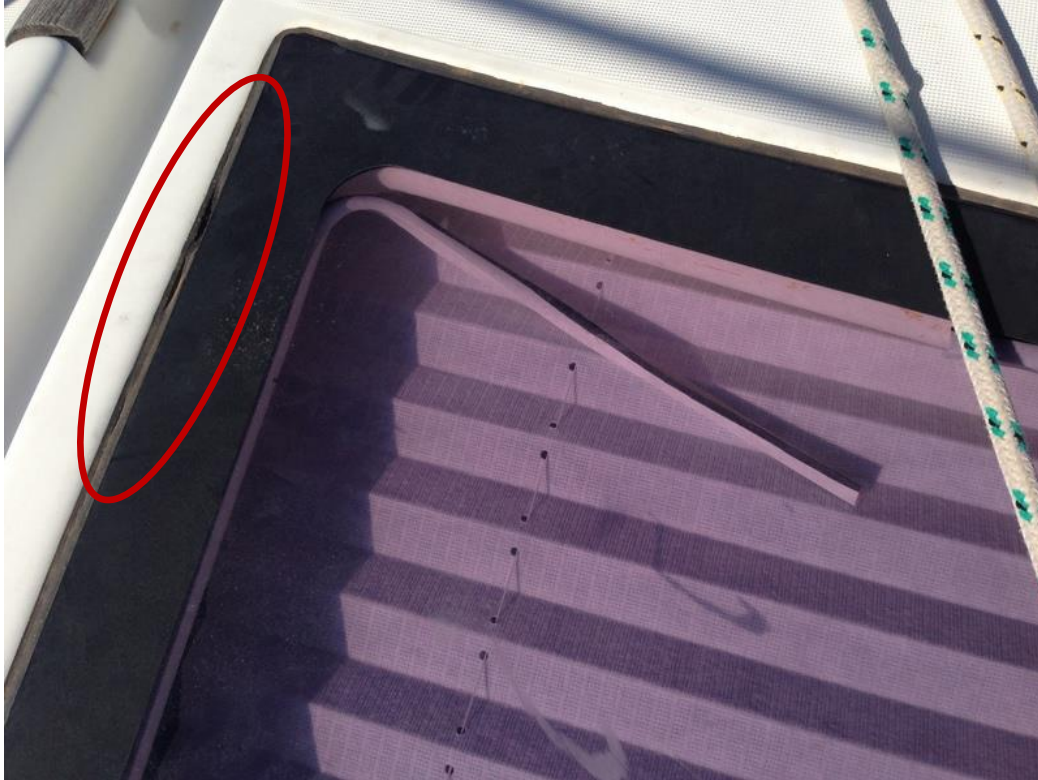
Some black sikaflex sealing places are not in place on side of coach roof windows.

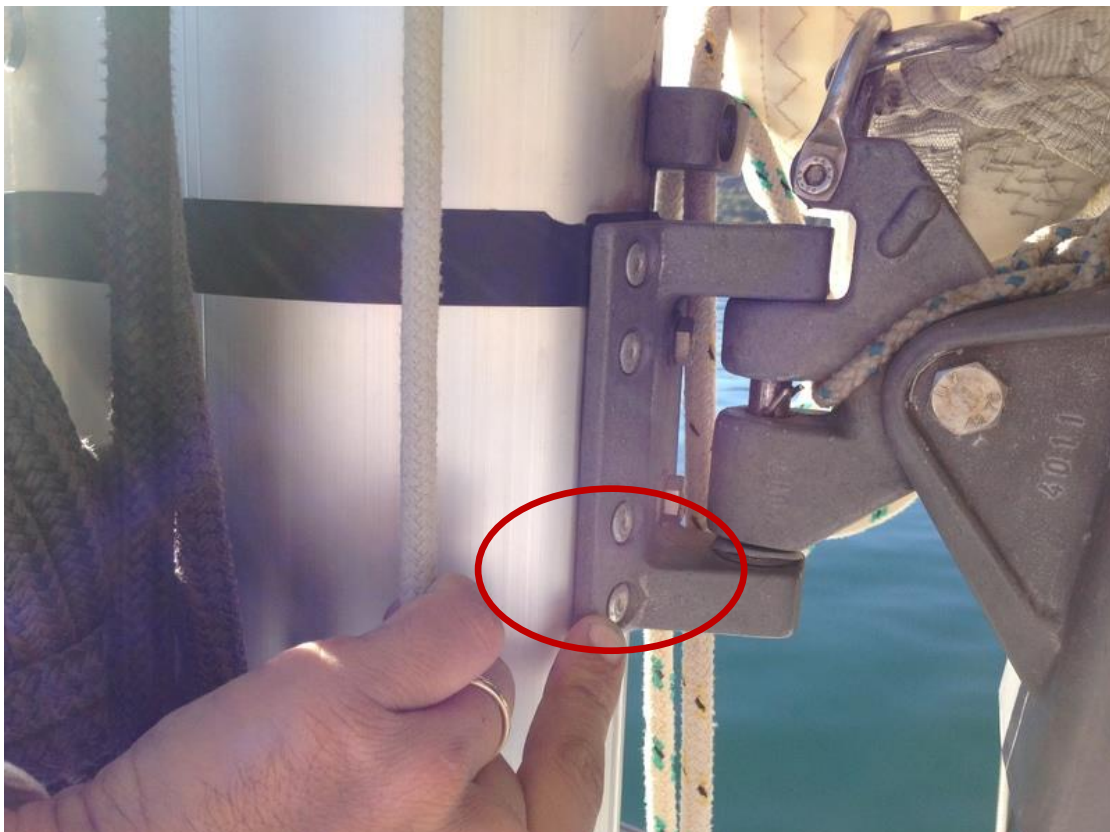
Boom connection hinge part is not tighten enough that is shown below. Rivets started moving and this will need a repairment.

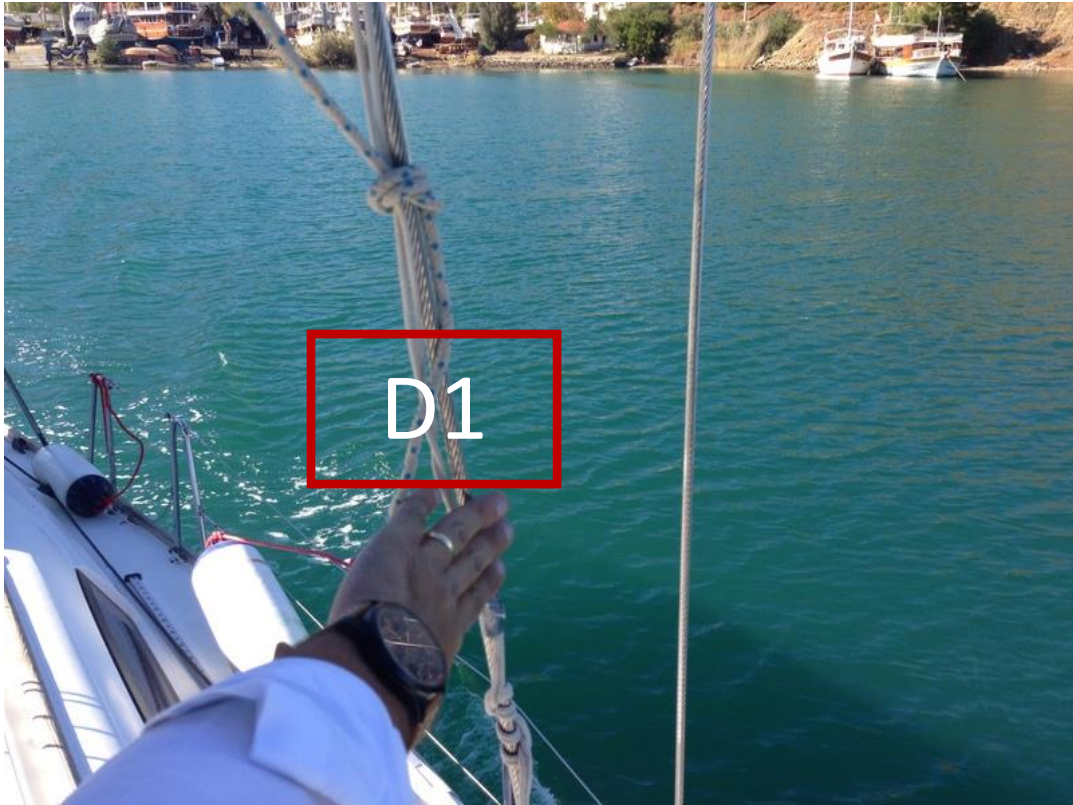
D1 shroud was too loosen. It was about 5% tension and it must be around 19% of pressure.

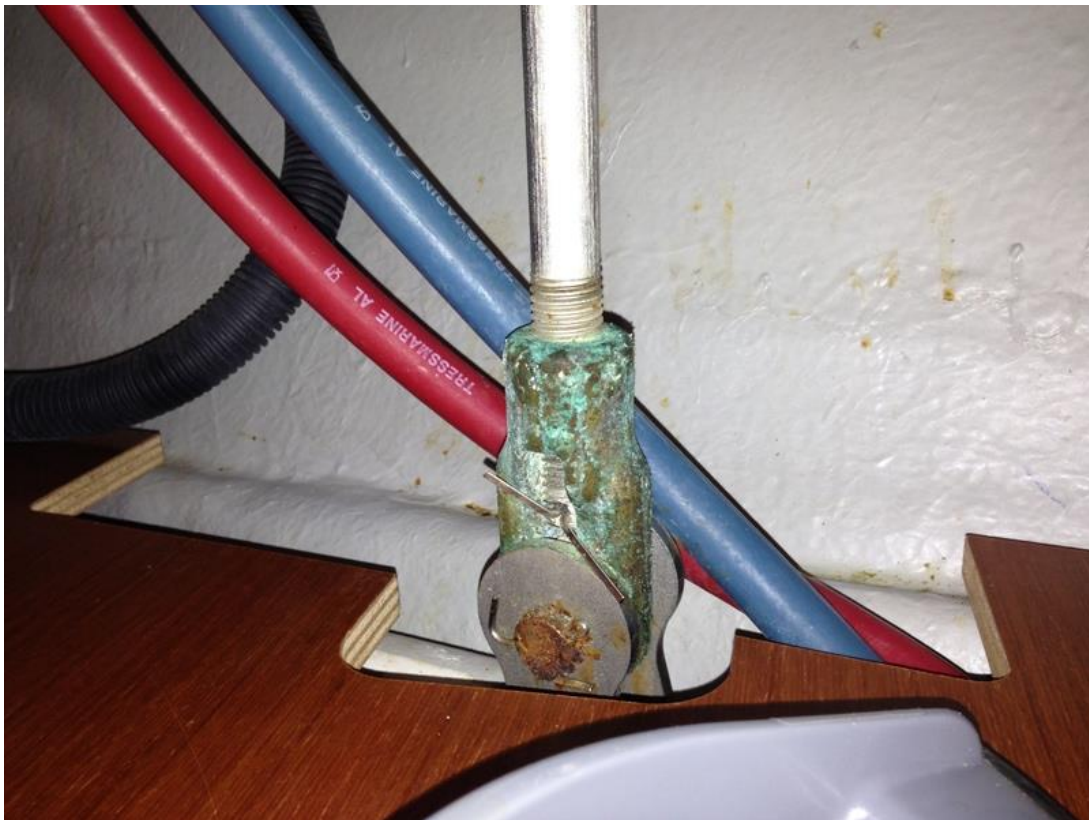
Water is leaking from the deck to the inside support parts of shrouds. Because of this made corrosion on seen products of both side of the boat. Steel pins must be cleaned.
