Marine Survey Report

/ Fethiye

Boat Name	[REDACTED]
Model	Moorings 41.3
Year	2011
HIN number	FR-SPBAN837A111
Boat builder	Beneteau
Flag	USA
LOA	12.17 m
Beam	3,96 m
Displacement	7680 kg
Vessel type	Monohull sloop sailing yacht
Engine model	Yanmar / 3JH5E

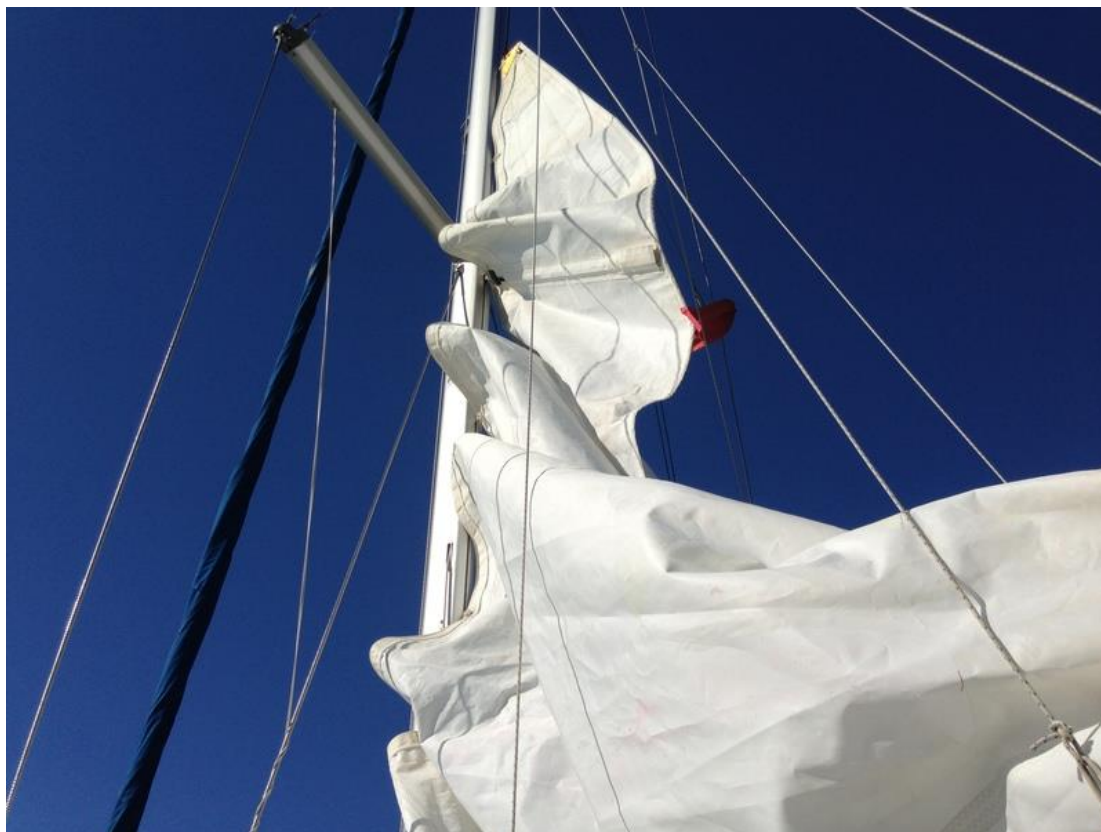
Mainsail stayed above the level of spreader.

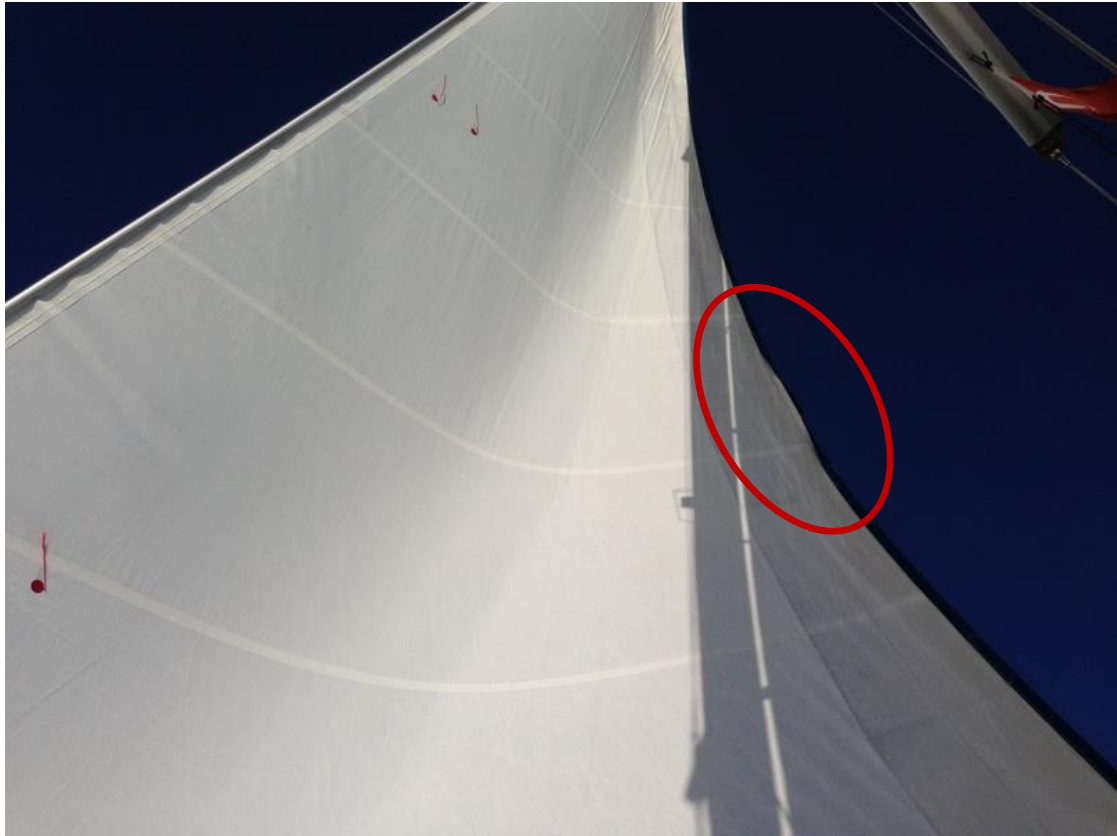
The furling genoa was in its place, rounding the furling foil. The white ultraviolet sacrificial strip on the genoa was decayed and weakened by UV degradation and should be replaced.

Leech side of genoa, uv protection cushion started tearing.

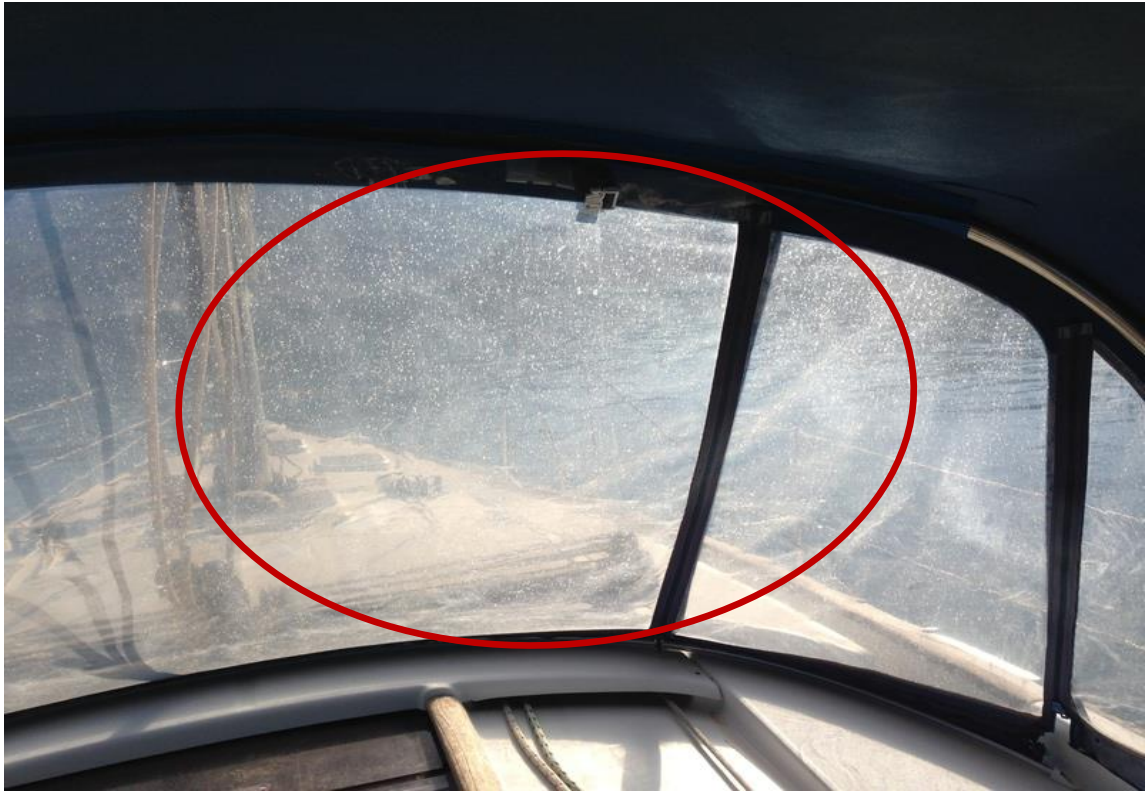
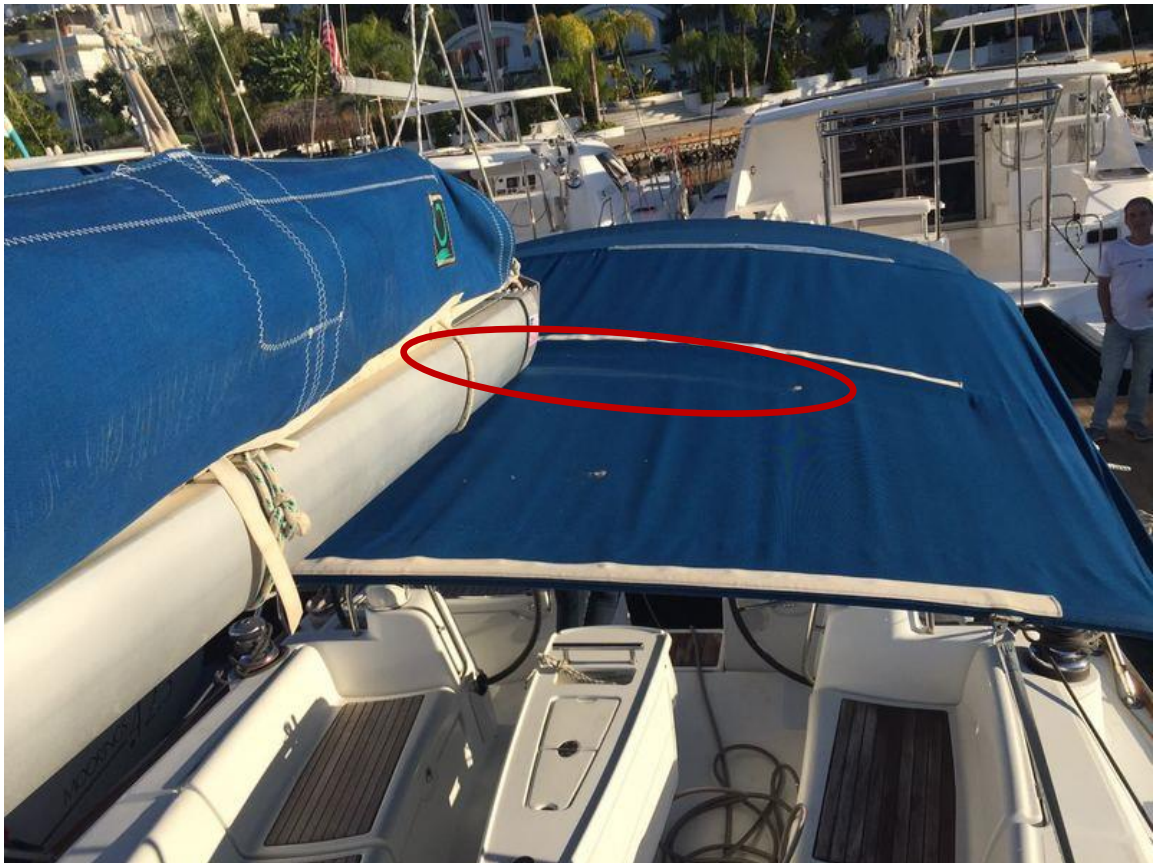
- Lazybag was fitted over the boom. The zip was working properly.
- Sprayhood windows were damaged from sun and it was not easy to see the bow side of the boat by looking behind the sprayhood.
- Bimini was in good condition. Only thing that, boom's aft edge was hitting the bimini and made a scratch on bimini.

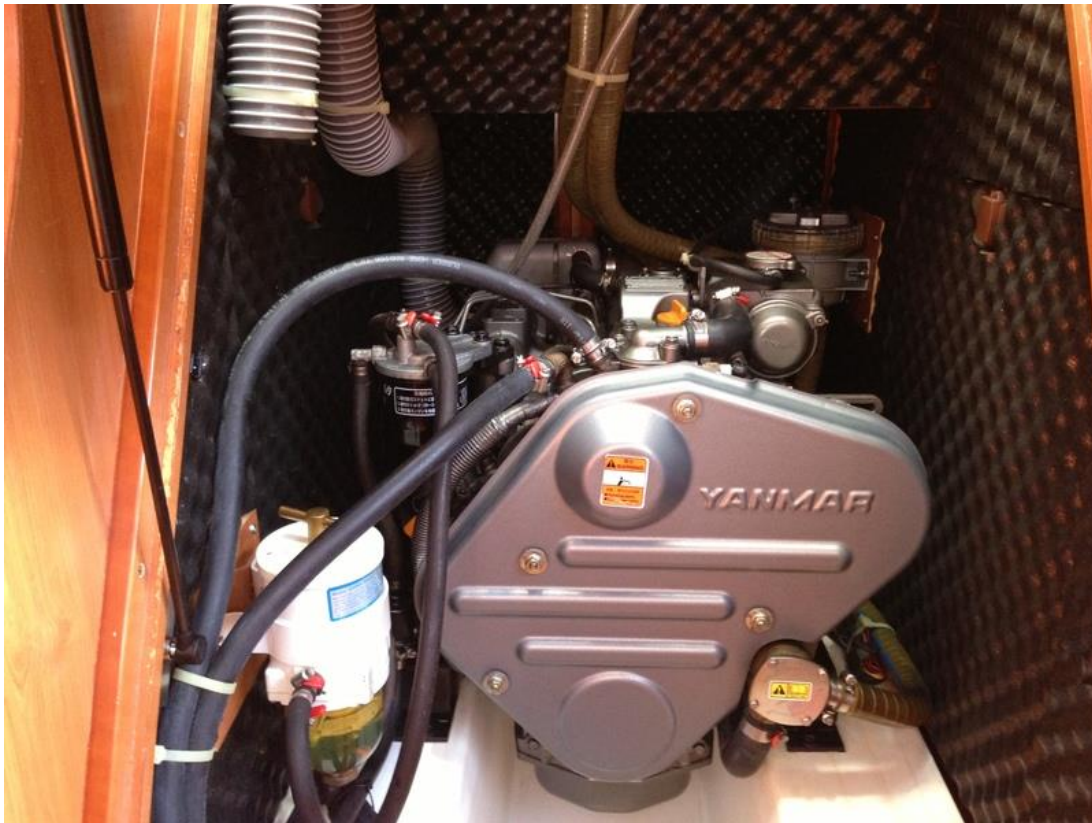
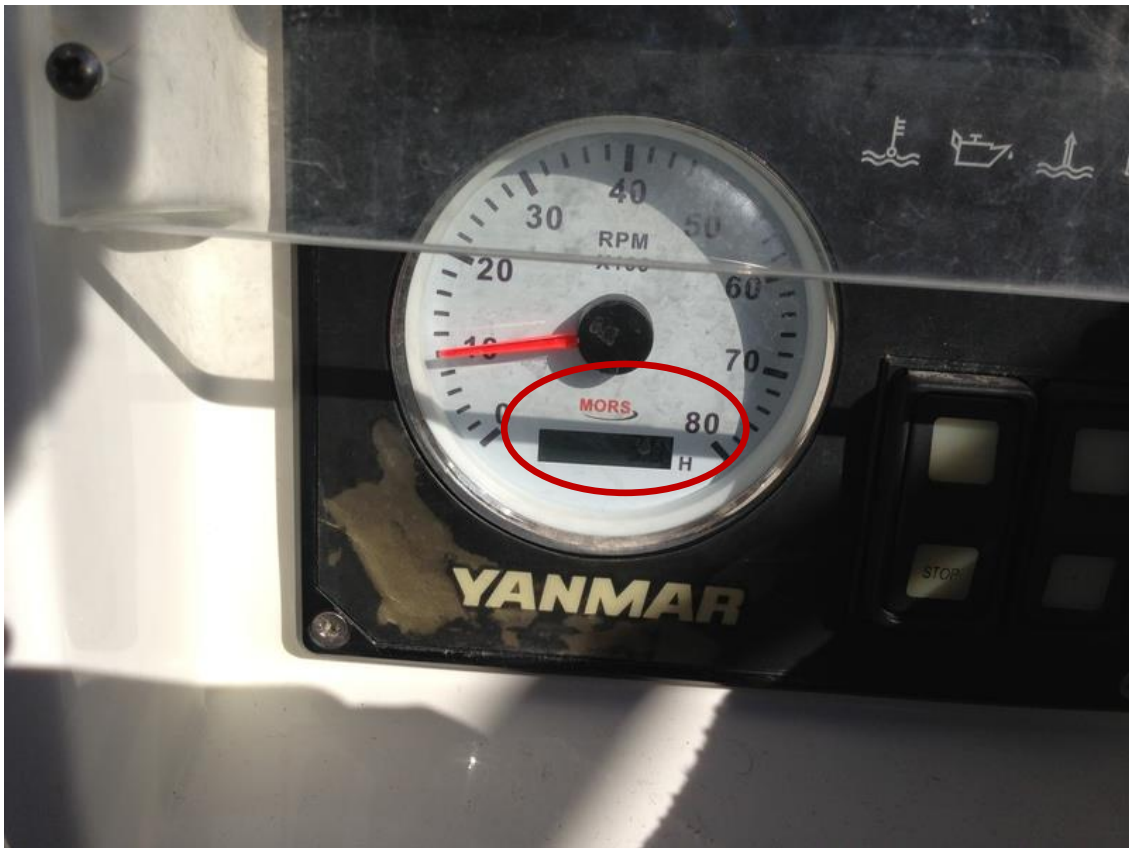
Rpm meter of engine was changed but it was not original. Engine hour was just four hours.

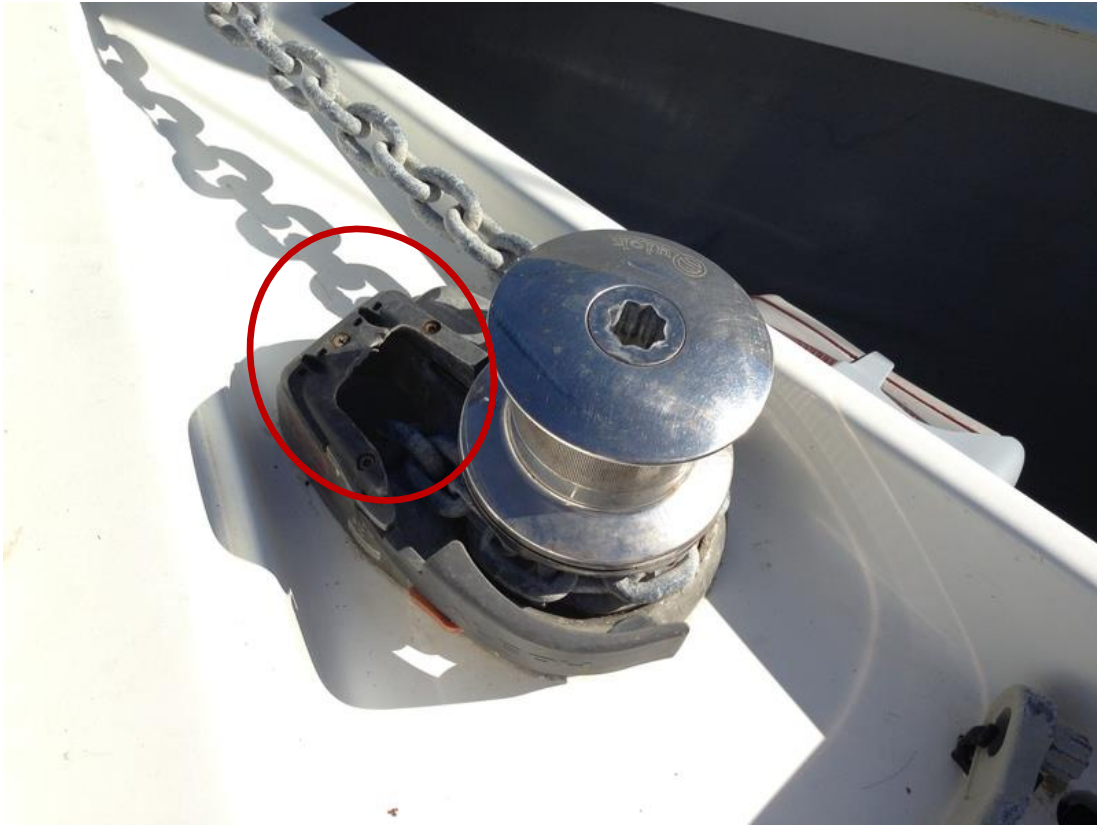
Chain cover of windlass was broken.

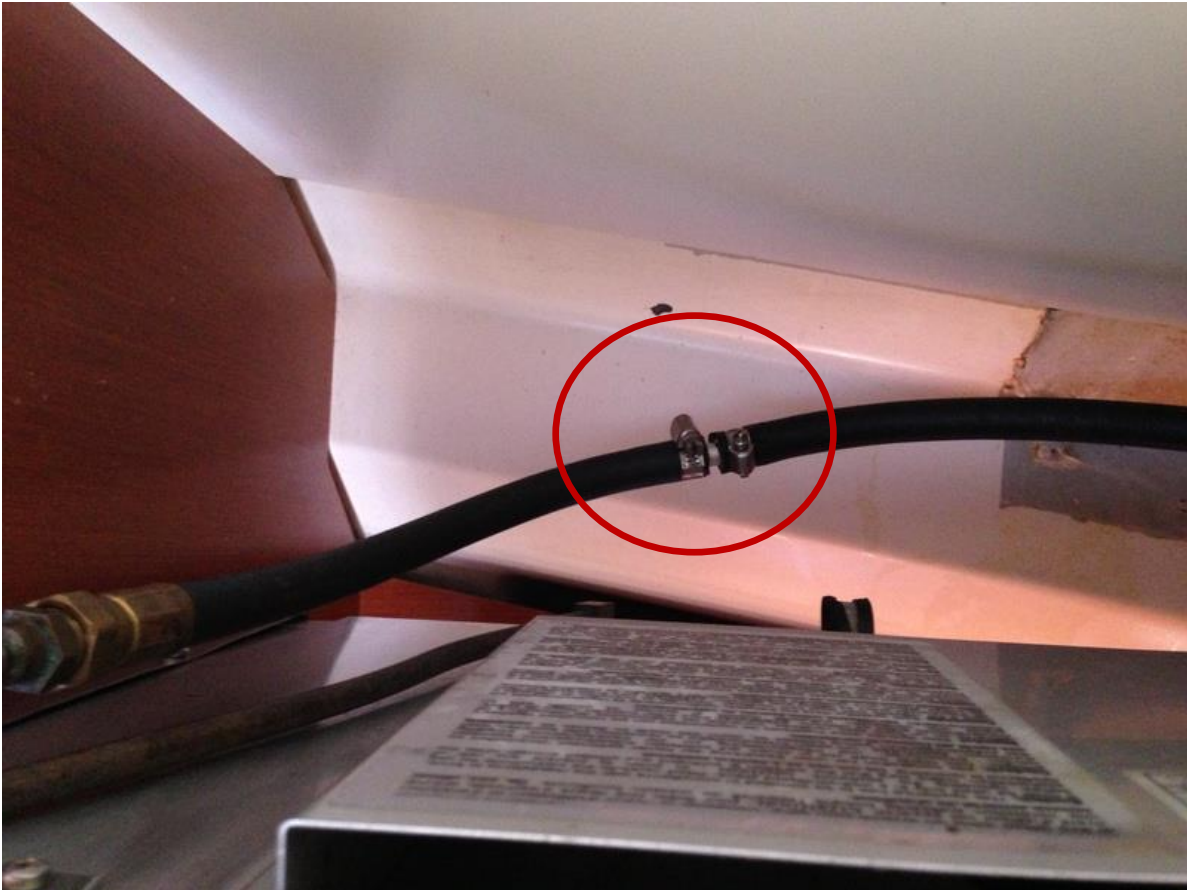
Gas pipe behind the oven was cut before and then connected by using a connector. This is not available for the gas system regulations.

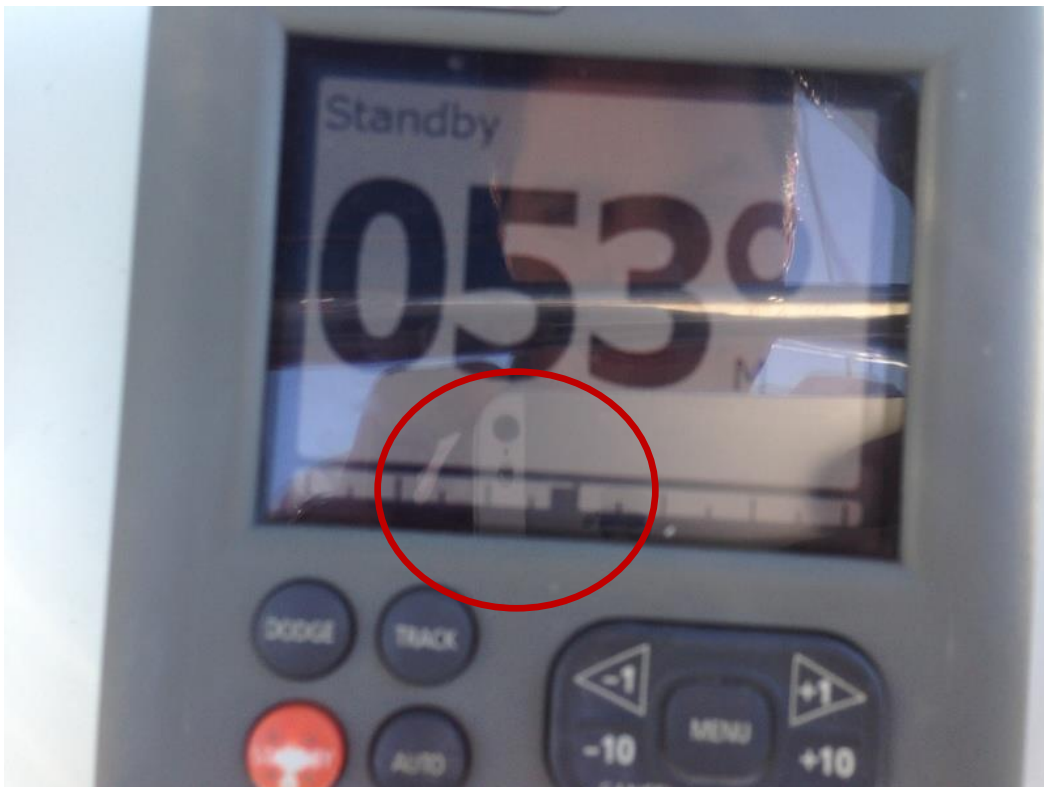
Autopilot's feedback must be calibrated. When you keep the boat straight, boat turns to starboard side. Rudder angle shows 5 degree more to the port side.

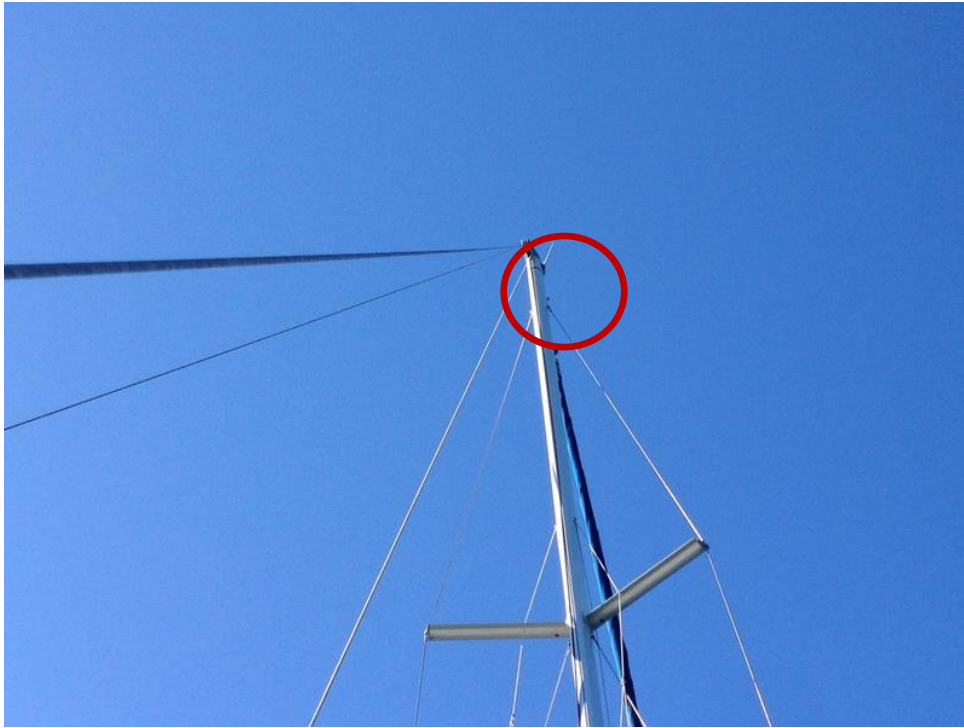
- VHF Antenna couldn't stand upright. It must be checked.
- There was not a windex wind indicator on the top of the mast.

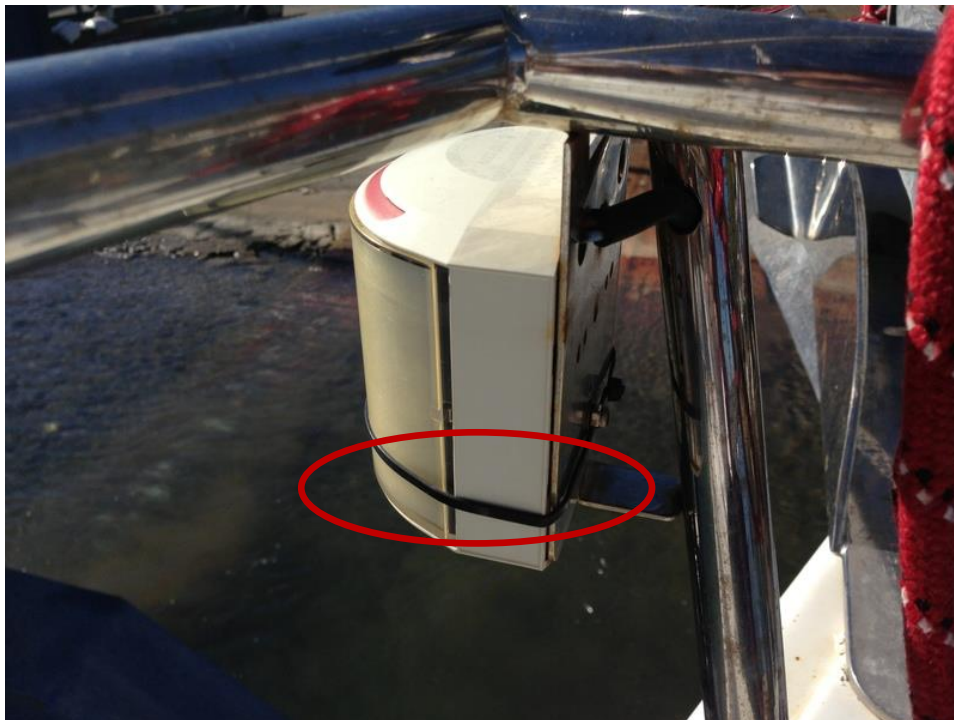
Port navigation light was supported by a plastic strip.

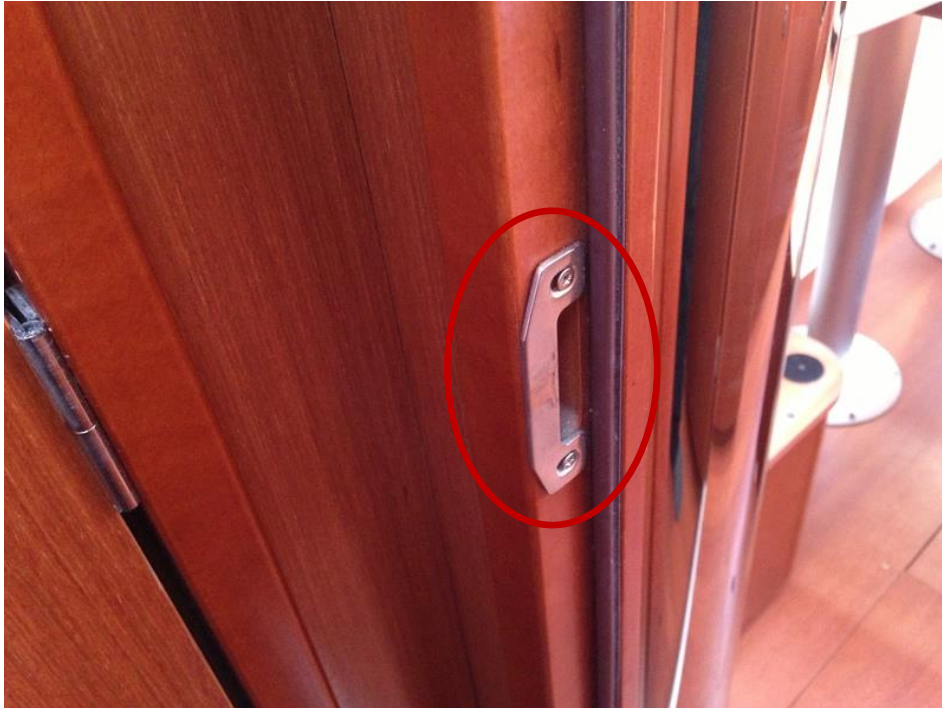
Bow cabin this door part needs to be tighten.

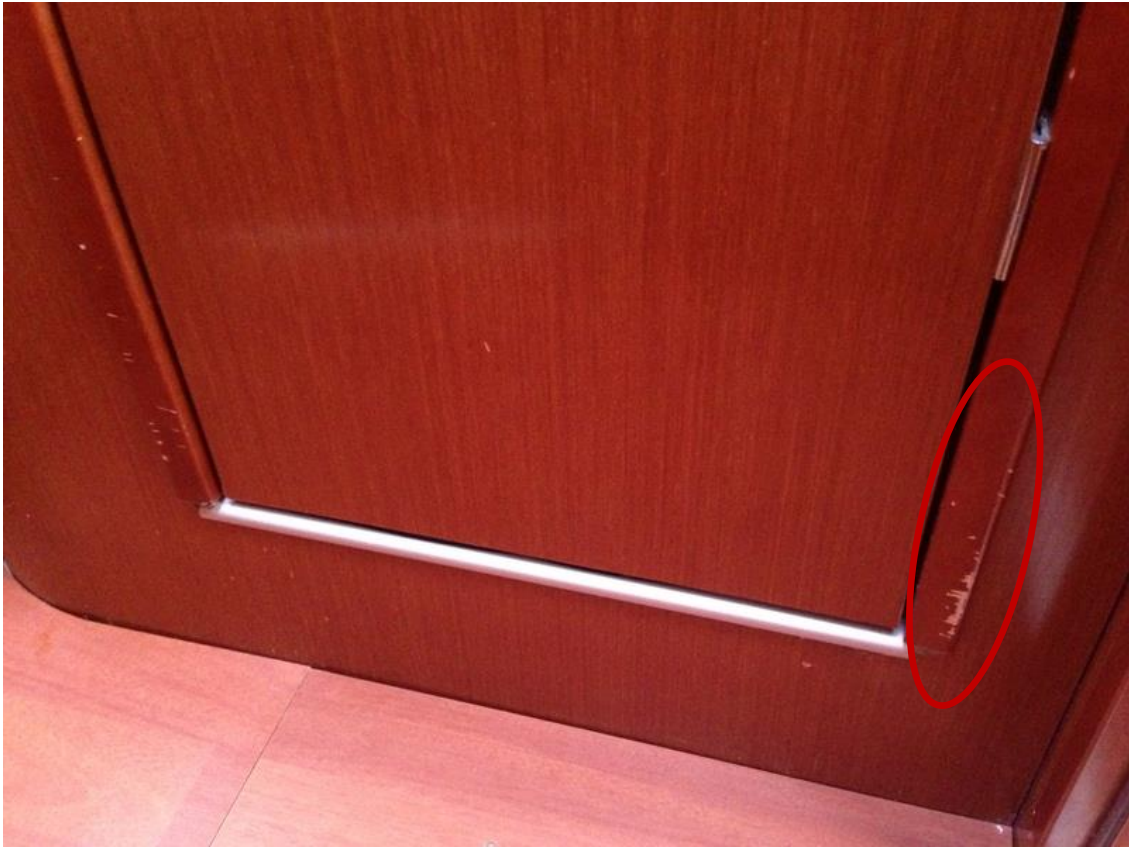
Cosmetic defects on saloon.

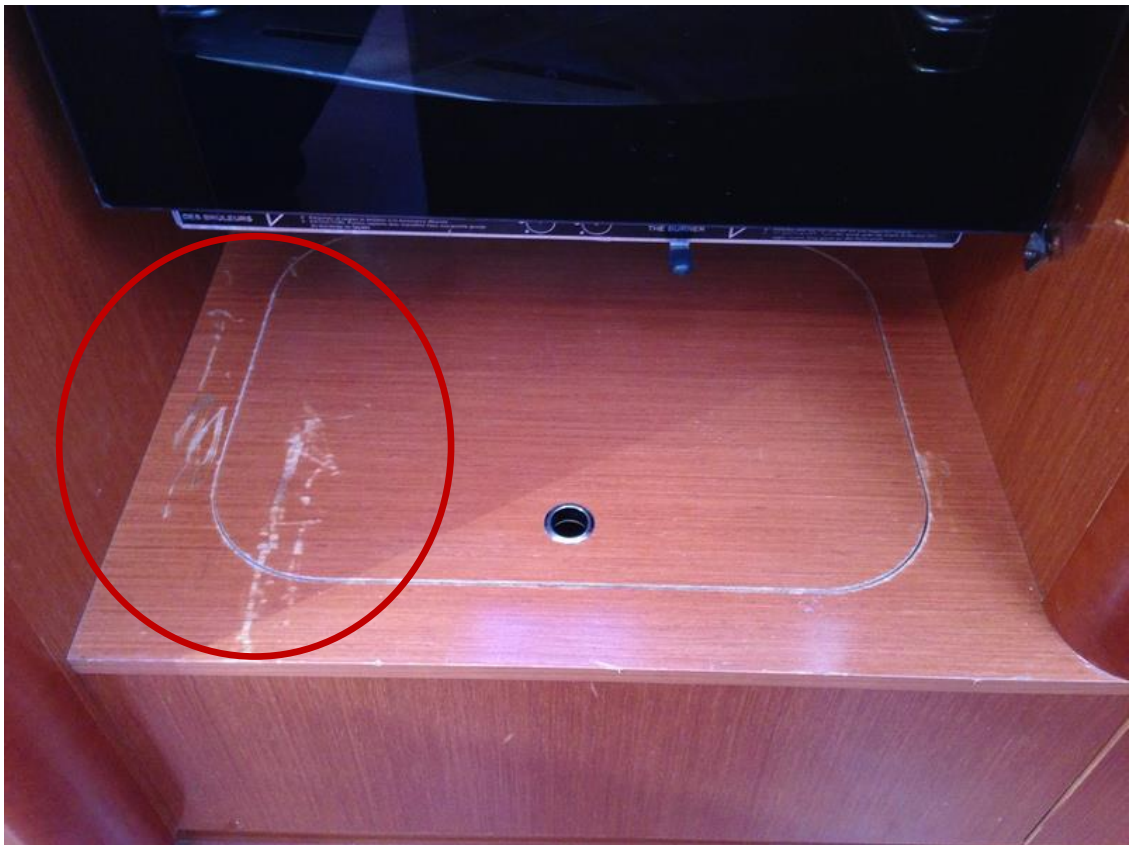
Cosmetic defects on saloon.

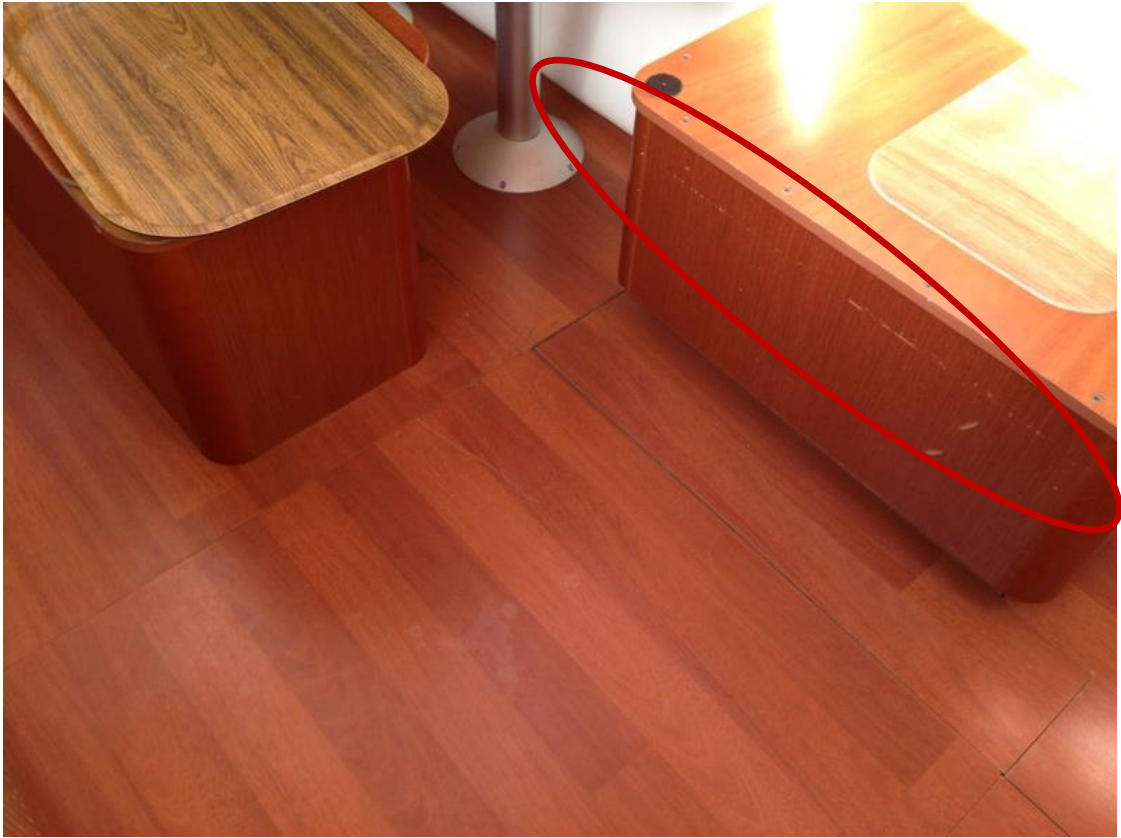
Cosmetic defects on saloon.

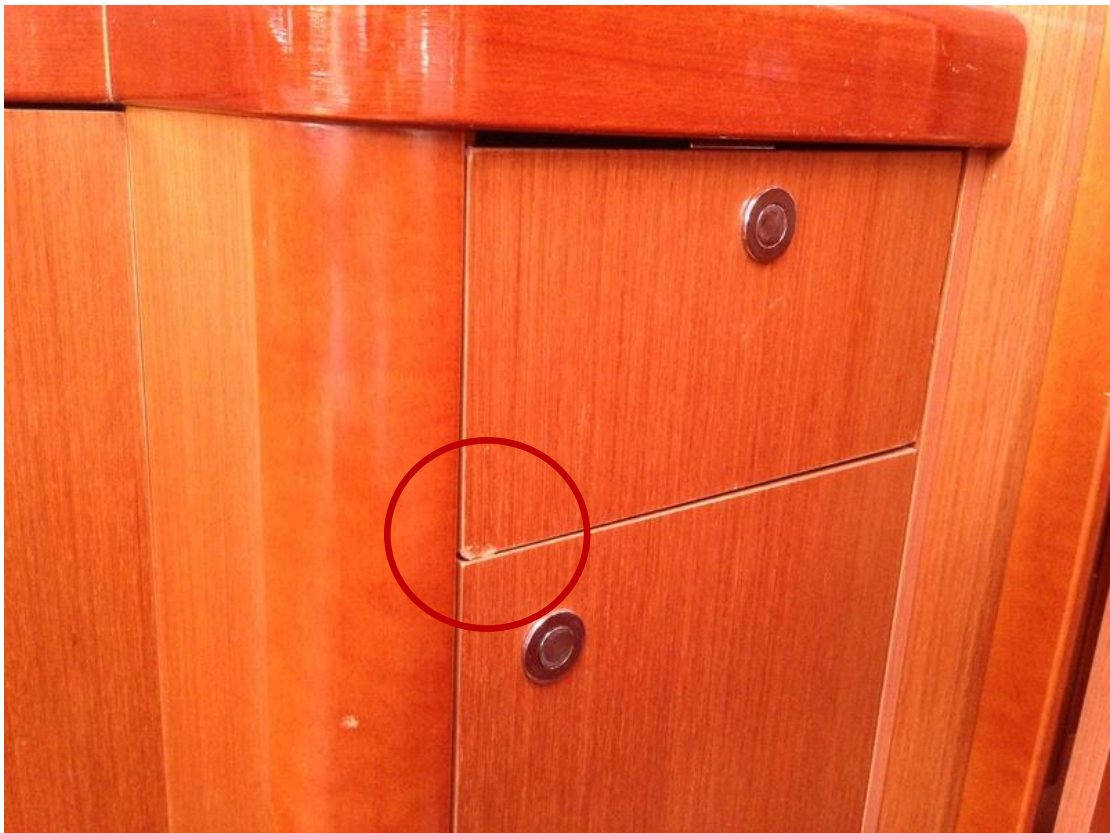
Cosmetic defects on saloon.

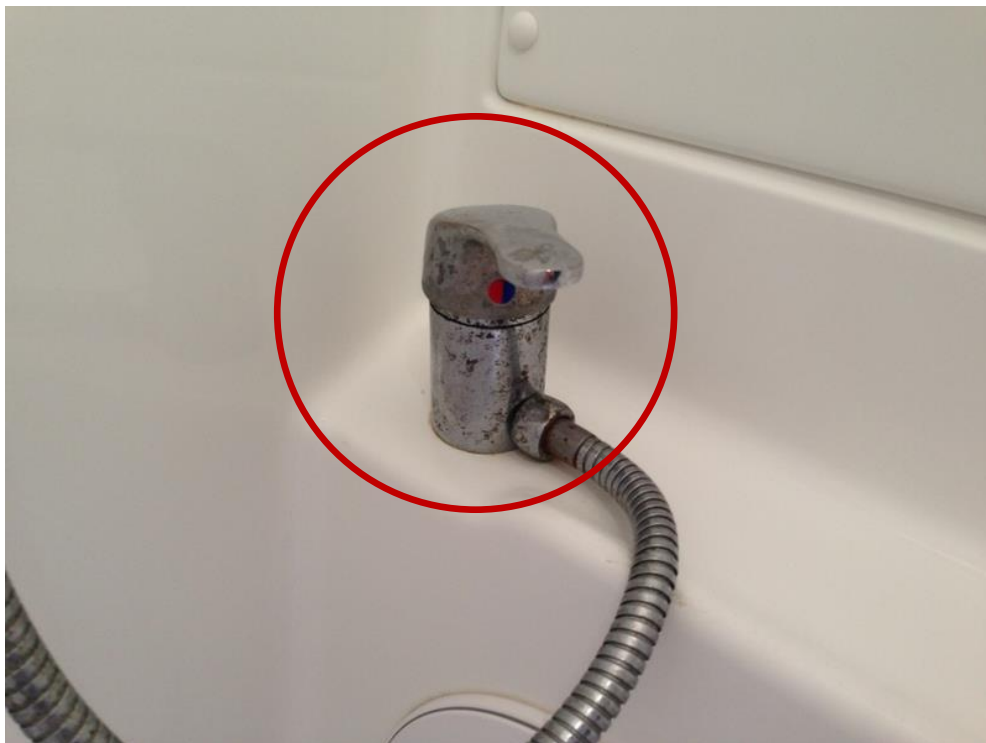
Steel parts at dayheads started corrosion.

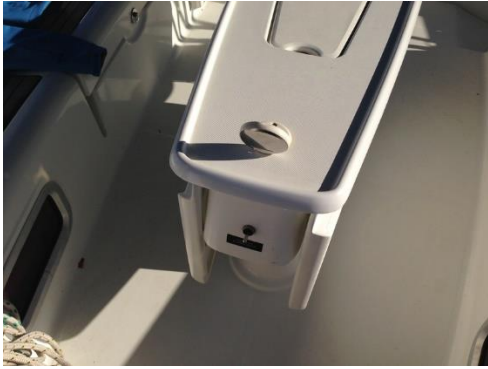
Cockpit courtesy desk light was not working.

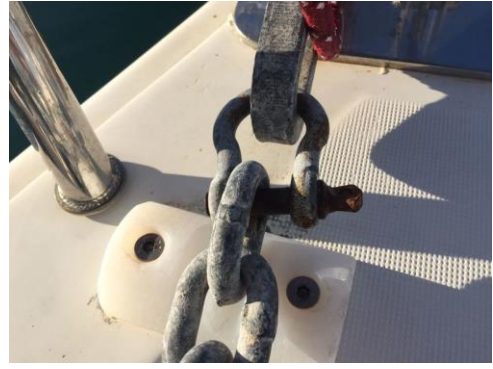
Mooring anchor chain shackle had corrosion.

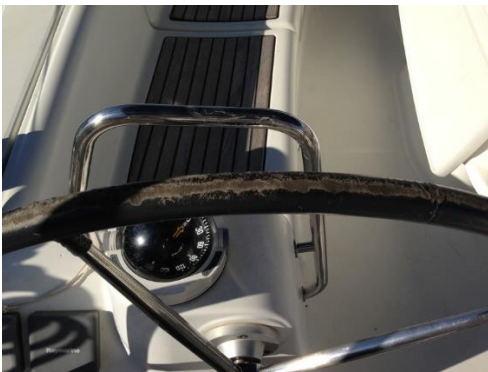
Starboard wheel is moving and need to be tighten.

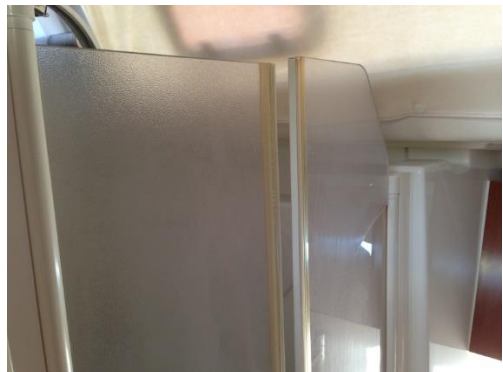
Pleksy shower door had a sctrach at dayhead in saloon

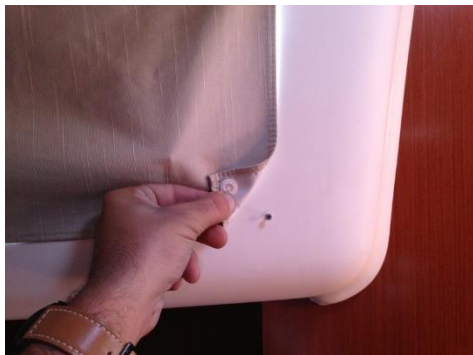
Some curtain holders were absent.

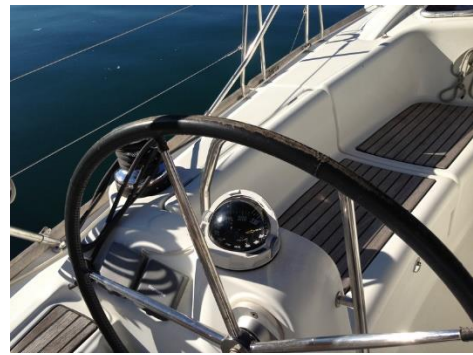
Wheel covers started losing their colour.
